Access Compliance Report

Public Rights-of-Way

(Curb Ramps)

Intersection ID: 50635	Main Street: RED_WATER_RD	Cross Street: BLUE_BLOSSOM_RD	Location: SE
ADA ID: 66D611E68FC8	Ramp Type: Perp	Initial Pass/Fail: Fail	Overall Compliance: No
Severity Score: 35			
Codes/Mitigation Info/Possible Solution		Field Measurements/Component Compliance

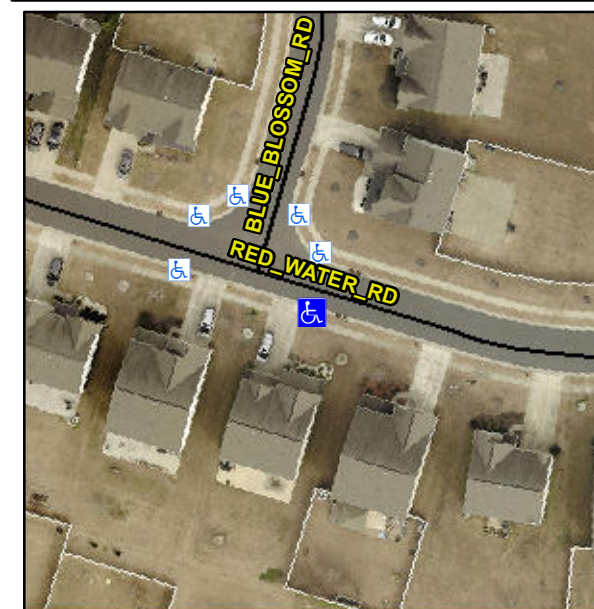
Not Found, R304.5.1, R304.2.2, R304.5.3

Compliance	Description	Data	Compliance	Description	Data
N/A	Ramp Length (in)	47.0	No	Ramp Slope (%)	14.2
No	Ramp Width (in)	47.0	No	Ramp XSlope (%)	3.0
N/A	Flare Type LT	N/A	N/A	Flare Type RT	N/A
N/A	Flare Slope LT (%)	N/A	N/A	Flare Slope RT (%)	N/A
N/A	Flare Traversable LT?	N/A	N/A	Flare Traversable RT?	N/A
N/A	Landing Length (in)	N/A	N/A	DWS Provided?	N/A
N/A	Landing Width (in)	N/A	N/A	DWS Contrast?	N/A
N/A	Landing Slope (%)	N/A	N/A	DWS Length (in)	N/A
N/A	Landing X Slope (%)	N/A	N/A	DWS Full Width?	N/A
N/A	Landing Curb? (Y/N)	N/A	N/A	DWS Offset (in)	N/A
N/A	Shared Landing?	N/A			
N/A	Gutter Ponding?	N/A	N/A	Gutter Slope (%)	N/A
N/A	Gutter Lip Ht (in)	N/A	N/A	Gutter X Slope (%)	N/A
N/A	Painted X Walk1?	No	N/A	Painted X Walk2?	N/A
	X Walk 1 Direction	To NE		X Walk 2 Direction	N/A
N/A	X Walk 1 Width (in)	N/A	N/A	X Walk 2 Width (in)	N/A
	X Walk 1 Slope (%)	1.9		X Walk 2 Slope (%)	N/A
	X Walk 1 X Slope (%)	2.2		X Walk 2 X Slope (%)	N/A

N/A	Ramp inside XWalk1?	N/A	N/A	Ramp inside XWalk2?	N/A
	Road Slope (%)	N/A	N/A	Clear Space?	N/A
	Road X Slope (%)	N/A	N/A	Clear Space to XWalk (in)	N/A
N/A	Any Obstructions?	N/A	N/A	Storm Grate/Utility Hazard?	N/A
	Obstruction Type			Storm Grate/Utility Type	
		N/A			N/A
			Yes	Surface Condition? (G/P)	Good

Possible Solutions:

Remove & Replace Entire Ramp.
