# Access Compliance Report

## Public Rights-of-Way

### (Curb Ramps)

Intersection ID: 48947	Main Street: DAVID_JENNINGS_AV	Cross Street: PEPPERPIKE_WY	Location: NE
ADA ID: 66DE78B4222C	Ramp Type: Perp	Initial Pass/Fail: Fail	Overall Compliance: No
Severity Score: 22.5			
Codes/Mitigation Info/Possible Solution		Field Measurements/Component Compliance

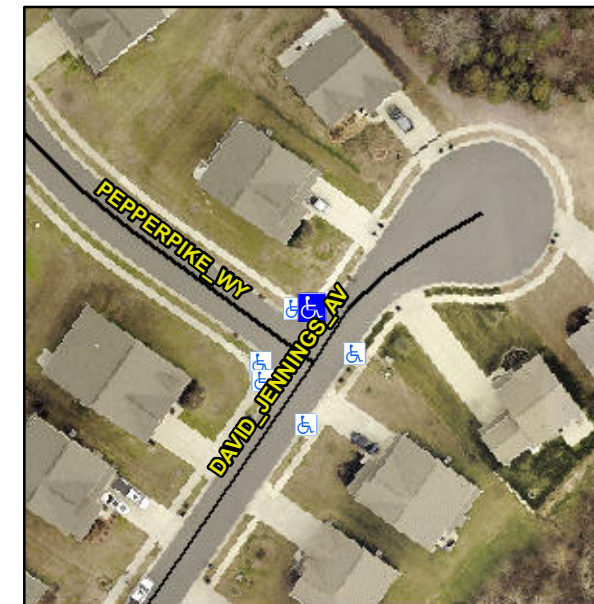
**Not Found, R304.5.1, R304.2.2, R304.5.3**

Compliance	Description	Data	Compliance	Description	Data
N/A	Ramp Length (in)	48.5	No	Ramp Slope (%)	10.5
No	Ramp Width (in)	47.5	No	Ramp XSlope (%)	2.6
N/A	Flare Type LT	N/A	N/A	Flare Type RT	N/A
N/A	Flare Slope LT (%)	N/A	N/A	Flare Slope RT (%)	N/A
N/A	Flare Traversable LT?	N/A	N/A	Flare Traversable RT?	N/A
N/A	Landing Length (in)	N/A	N/A	DWS Provided?	N/A
N/A	Landing Width (in)	N/A	N/A	DWS Contrast?	N/A
N/A	Landing Slope (%)	N/A	N/A	DWS Length (in)	N/A
N/A	Landing X Slope (%)	N/A	N/A	DWS Full Width?	N/A
N/A	Landing Curb? (Y/N)	N/A	N/A	DWS Offset (in)	N/A
N/A	Shared Landing?	N/A			
N/A	Gutter Ponding?	N/A	N/A	Gutter Slope (%)	N/A
N/A	Gutter Lip Ht (in)	N/A	N/A	Gutter X Slope (%)	N/A
N/A	Painted X Walk1?	No	N/A	Painted X Walk2?	N/A
	X Walk 1 Direction	To SE		X Walk 2 Direction	N/A
N/A	X Walk 1 Width (in)	N/A	N/A	X Walk 2 Width (in)	N/A
	X Walk 1 Slope (%)	0.7		X Walk 2 Slope (%)	N/A
	X Walk 1 X Slope (%)	1.6		X Walk 2 X Slope (%)	N/A

N/A	Ramp inside XWalk1?	N/A	N/A	Ramp inside XWalk2?	N/A
	Road Slope (%)	N/A	N/A	Clear Space?	N/A
	Road X Slope (%)	N/A	N/A	Clear Space to XWalk (in)	N/A
N/A	Any Obstructions?	N/A	N/A	Storm Grate/Utility Hazard?	N/A
	Obstruction Type			Storm Grate/Utility Type	
		N/A			N/A
			Yes	Surface Condition? (G/P)	Good

**Remove & Replace Entire Ramp.**
