## **Access Compliance Report Public Rights-of-Way** (Curb Ramps)

Intersection ID: 10038380 Main Street: SOUTH BV **Cross Street: N/A** Location: SE Initial Pass/Fail: Fail **Severity Score:** ADA ID: 66EEB9366B15 Ramp Type: Perp **Overall Compliance: No** 25

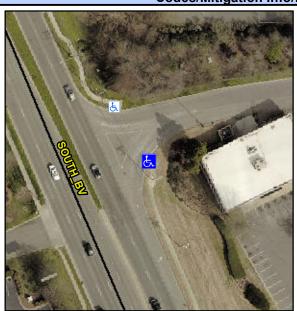
**ENTRANCE** Street 1 Name Stop Condition-Street 2 StopSign Street 2 Name N/A Stop Condition-Street 1 N/A Possible Solutions: Remove & Replace Entire Ramp. Surveyor Notes: N/A PROW/ADA: Not Found, R304.2.2

Field Measurements/Component Compliance						
Compliance Description		Data	Comp	liance	Description	Data
N/A	Ramp Length (in)	121.0	No	Ramp	Slope (%)	12.5
Yes	Ramp Width (in)	48.0	Yes	Ramp	XSlope (%)	1.6
N/A	Flare Type LT	N/A	N/A	Flare	Type RT	N/A
N/A	Flare Slope LT (%)	N/A	N/A	Flare	Slope RT (%)	N/A
N/A	Flare Traversable LT?	N/A	N/A	Flare	Traversable RT?	N/A
N/A	Landing Length (in)	N/A	N/A	DWS	Provided?	N/A
N/A	Landing Width (in)	N/A	N/A	DWS	Contrast?	N/A
N/A	Landing Slope (%)	N/A	N/A	DWS	Length (in)	N/A
N/A	Landing X Slope (%)	N/A	N/A	DWS	Full Width?	N/A
N/A	Landing Curb? (Y/N)	N/A	N/A	DWS	Offset (in)	N/A
N/A	Shared Landing?	N/A				
N/A	Gutter Ponding?	N/A	N/A	Gutte	r Slope (%)	N/A
N/A	Gutter Lip Ht (in)	N/A	N/A	Gutte	r X Slope (%)	N/A
N/A	Painted X Walk1?	No	N/A	Painte	ed X Walk2?	N/A
	X Walk 1 Direction	To N		X Wal	k 2 Direction	N/A
N/A	X Walk 1 Width (in)	N/A	N/A	X Wal	k 2 Width (in)	N/A
	X Walk 1 Slope (%)	0.1		X Wal	k 2 Slope (%)	N/A

X Walk 1 X Slope (%)	0.3		X Wal	k 2 X Slope (%)	N/A
N/A	Ramp inside XWalk1?	N/A	N/A	Ramp	inside XWalk2?	N/A
	Road Slope (%)	N/A	N/A	Clear	Space?	N/A
	Road X Slope (%)	N/A	N/A	Clear	Space to XWalk (in)	N/A
N/A	Any Obstructions?	N/A	N/A	Storm	Grate/Utility Hazard?	N/A
	Obstruction Type			Storm	Grate/Utility Type	
		N/A				N/A
			Yes	Surfac	ce Condition? (G/P)	Good
