Access Compliance Report

Public Rights-of-Way

(Curb Ramps)

Intersection ID: 48953	Main Street: DAVID_JENNINGS_AV	Cross Street: GATESMILLS_AV	Location: W
ADA ID: 66F8EB4179B5	Ramp Type: Perp	Initial Pass/Fail: Fail	Overall Compliance: No
Severity Score: 12.5			
Codes/Mitigation Info/Possible Solution		Field Measurements/Component Compliance

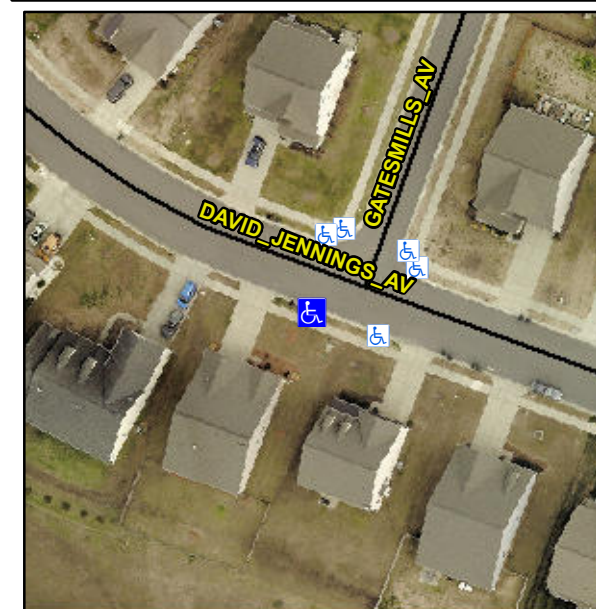
Compliance	Description	Data	Compliance	Description	Data
N/A	Ramp Length (in)	46.5	No	Ramp Slope (%)	10.1
Yes	Ramp Width (in)	48.0	Yes	Ramp XSlope (%)	1.5
N/A	Flare Type LT	N/A	N/A	Flare Type RT	N/A
N/A	Flare Slope LT (%)	N/A	N/A	Flare Slope RT (%)	N/A
N/A	Flare Traversable LT?	N/A	N/A	Flare Traversable RT?	N/A
N/A	Landing Length (in)	N/A	N/A	DWS Provided?	N/A
N/A	Landing Width (in)	N/A	N/A	DWS Contrast?	N/A
N/A	Landing Slope (%)	N/A	N/A	DWS Length (in)	N/A
N/A	Landing X Slope (%)	N/A	N/A	DWS Full Width?	N/A
N/A	Landing Curb? (Y/N)	N/A	N/A	DWS Offset (in)	N/A
N/A	Shared Landing?	N/A			
N/A	Gutter Ponding?	N/A	N/A	Gutter Slope (%)	N/A
N/A	Gutter Lip Ht (in)	N/A	N/A	Gutter X Slope (%)	N/A
N/A	Painted X Walk1?	No	N/A	Painted X Walk2?	N/A
	X Walk 1 Direction	To N		X Walk 2 Direction	N/A
N/A	X Walk 1 Width (in)	N/A	N/A	X Walk 2 Width (in)	N/A
	X Walk 1 Slope (%)	1.3		X Walk 2 Slope (%)	N/A
	X Walk 1 X Slope (%)	1.2		X Walk 2 X Slope (%)	N/A

N/A	Ramp inside XWalk1?	N/A	N/A	Ramp inside XWalk2?	N/A
	Road Slope (%)	N/A	N/A	Clear Space?	N/A
	Road X Slope (%)	N/A	N/A	Clear Space to XWalk (in)	N/A
N/A	Any Obstructions?	N/A	N/A	Storm Grate/Utility Hazard?	N/A
	Obstruction Type			Storm Grate/Utility Type	
		N/A			N/A
			Yes	Surface Condition? (G/P)	Good

Possible Solutions:

Remove & Replace Entire Ramp.
