# Access Compliance Report

## Public Rights-of-Way

Intersection ID: 25496	Main Street: GRIMMERSBOROUGH_LN	Cross Street: PROVIDENCE_PLANTATION_LN	Location: NW
ADA ID: 6700DB3FBD27	Ramp Type: Perp	Initial Pass/Fail: Fail	Overall Compliance: No
Severity Score: 21.25			
Codes/Mitigation Info/Possible Solution		Field Measurements/Component Compliance

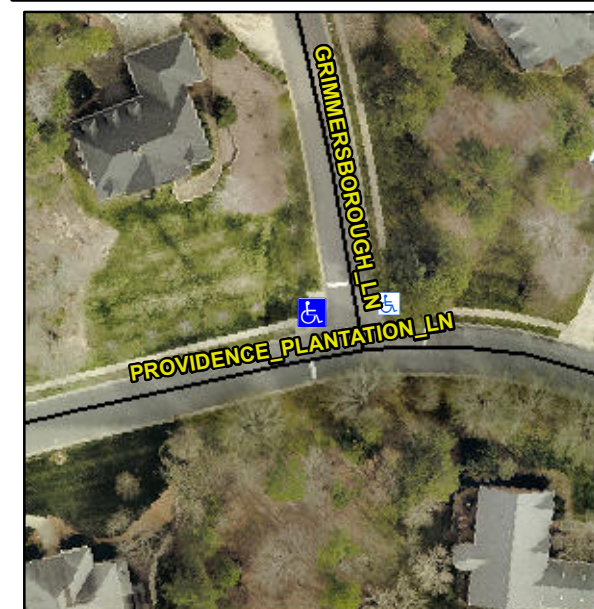
**Not Found, R304.5.1, R304.5.3**

Compliance	Description	Data	Compliance	Description	Data
N/A	Ramp Length (in)	49.5	Yes	Ramp Slope (%)	6.8
No	Ramp Width (in)	46.5	No	Ramp XSlope (%)	5.1
N/A	Flare Type LT	N/A	N/A	Flare Type RT	N/A
N/A	Flare Slope LT (%)	N/A	N/A	Flare Slope RT (%)	N/A
N/A	Flare Traversable LT?	N/A	N/A	Flare Traversable RT?	N/A
N/A	Landing Length (in)	N/A	N/A	DWS Provided?	N/A
N/A	Landing Width (in)	N/A	N/A	DWS Contrast?	N/A
N/A	Landing Slope (%)	N/A	N/A	DWS Length (in)	N/A
N/A	Landing X Slope (%)	N/A	N/A	DWS Full Width?	N/A
N/A	Landing Curb? (Y/N)	N/A	N/A	DWS Offset (in)	N/A
N/A	Shared Landing?	N/A			
N/A	Gutter Ponding?	N/A	N/A	Gutter Slope (%)	N/A
N/A	Gutter Lip Ht (in)	N/A	N/A	Gutter X Slope (%)	N/A
N/A	Painted X Walk1?	No	N/A	Painted X Walk2?	N/A
	X Walk 1 Direction	To E		X Walk 2 Direction	N/A
N/A	X Walk 1 Width (in)	N/A	N/A	X Walk 2 Width (in)	N/A
	X Walk 1 Slope (%)	1.1		X Walk 2 Slope (%)	N/A
	X Walk 1 X Slope (%)	6.0		X Walk 2 X Slope (%)	N/A

N/A	Ramp inside XWalk1?	N/A	N/A	Ramp inside XWalk2?	N/A
	Road Slope (%)	N/A	N/A	Clear Space?	N/A
	Road X Slope (%)	N/A	N/A	Clear Space to XWalk (in)	N/A
N/A	Any Obstructions?	N/A	N/A	Storm Grate/Utility Hazard?	N/A
	Obstruction Type			Storm Grate/Utility Type	
		N/A			N/A
			Yes	Surface Condition? (G/P)	Good

**Remove & Replace Entire Ramp.**
