Access Compliance Report Public Rights-of-Way (Curb Ramps)

Intersection ID: 11780 Main Street: E 20TH ST **Cross Street: PEGRAM ST** Location:

Overall Compliance: No ADA ID: 6703DCD5DA80 Ramp Type: PerpDiag Initial Pass/Fail: Fail Severity Score: 21.25

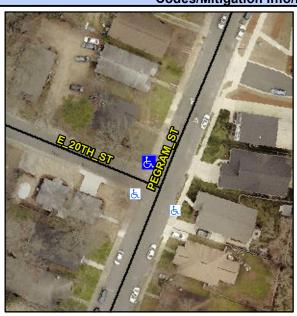
Total Cost: 3200.00 Compliance Description <u>Data</u> Compliance Description Data No N/A Ramp Length (in) 44.0 Ramp Slope (%) 11.4 Yes No Ramp Width (in) 41.0 Ramp XSlope (%) 1.2 N/A N/A Flare Type LT N/A Flare Type RT N/A N/A N/A Flare Slope RT (%) N/A Flare Slope LT (%) N/A N/A Flare Traversable LT? N/A N/A Flare Traversable RT? N/A N/A N/A N/A **DWS Provided?** N/A Landing Length (in) N/A Landing Width (in) N/A N/A **DWS Contrast?** N/A N/A N/A Landing Slope (%) N/A DWS Length (in) N/A N/A Landing X Slope (%) N/A N/A DWS Full Width? N/A N/A Landing Curb? (Y/N) N/A N/A DWS Offset (in) N/A N/A N/A Shared Landing? N/A **Gutter Ponding?** N/A Gutter Slope (%) N/A Yes N/A Gutter Lip Ht (in) 2.0 N/A Gutter X Slope (%) N/A N/A Painted X Walk1? No N/A Painted X Walk2? No X Walk 1 Direction To SW X Walk 2 Direction To SE N/A N/A X Walk 1 Width (in) X Walk 2 Width (in) N/A X Walk 1 Slope (%) X Walk 2 Slope (%) 0.1 4.6 X Walk 2 X Slope (%) X Walk 1 X Slope (%) 1.7 1.1 N/A N/A N/A Ramp inside XWalk2? N/A Ramp inside XWalk1? Road Slope (%) 1.0 N/A Clear Space? N/A N/A Road X Slope (%) Clear Space to XWalk (in) N/A 0.2 N/A N/A Any Obstructions? N/A Storm Grate/Utility Hazard? N/A **Obstruction Type** Storm Grate/Utility Type N/A

Possible Solutions: Remove & Replace Curb Ramp With Two New Directional Ramps or Equivalent. Surveyor Notes: N/A PROW/ADA: Not Found, R304.5.1, R304.2.2
