Access Compliance Report

Public Rights-of-Way

(Curb Ramps)

Intersection ID: 42513	Main Street: ELM_LN	Cross Street: INDIGO_RW	Location: E
ADA ID: 67184025CB73	Ramp Type: PerpDiag	Initial Pass/Fail: Fail	Overall Compliance: No
Severity Score: 25			
Codes/Mitigation Info/Possible Solution		Field Measurements/Component Compliance

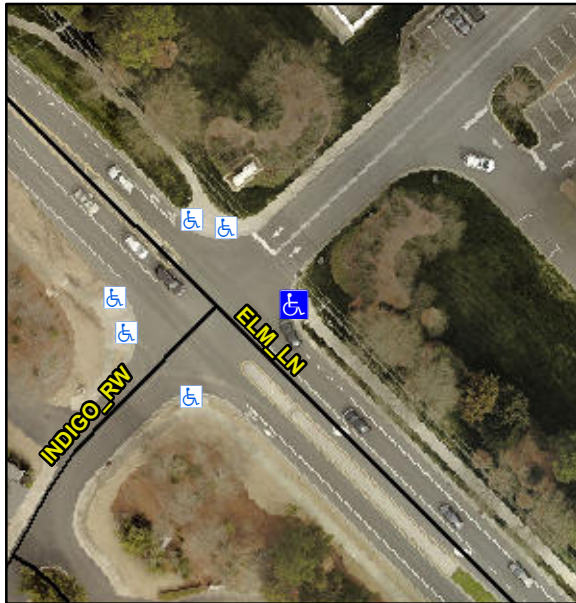
Not Found, R304.2.2, R304.5.3

Compliance	Description	Data	Compliance	Description	Data
N/A	Ramp Length (in)	40.0	No	Ramp Slope (%)	9.4
Yes	Ramp Width (in)	48.0	No	Ramp XSlope (%)	5.4
N/A	Flare Type LT	N/A	N/A	Flare Type RT	N/A
N/A	Flare Slope LT (%)	N/A	N/A	Flare Slope RT (%)	N/A
N/A	Flare Traversable LT?	N/A	N/A	Flare Traversable RT?	N/A
N/A	Landing Length (in)	N/A	N/A	DWS Provided?	N/A
N/A	Landing Width (in)	N/A	N/A	DWS Contrast?	N/A
N/A	Landing Slope (%)	N/A	N/A	DWS Length (in)	N/A
N/A	Landing X Slope (%)	N/A	N/A	DWS Full Width?	N/A
N/A	Landing Curb? (Y/N)	N/A	N/A	DWS Offset (in)	N/A
N/A	Shared Landing?	N/A			
N/A	Gutter Ponding?	N/A	N/A	Gutter Slope (%)	N/A
N/A	Gutter Lip Ht (in)	N/A	N/A	Gutter X Slope (%)	N/A
N/A	Painted X Walk1?	No	N/A	Painted X Walk2?	No
	X Walk 1 Direction	To NW		X Walk 2 Direction	To SW
N/A	X Walk 1 Width (in)	N/A	N/A	X Walk 2 Width (in)	N/A
	X Walk 1 Slope (%)	1.9		X Walk 2 Slope (%)	9.2
	X Walk 1 X Slope (%)	8.4		X Walk 2 X Slope (%)	2.6

N/A	Ramp inside XWalk1?	N/A	N/A	Ramp inside XWalk2?	N/A
	Road Slope (%)	4.8	N/A	Clear Space?	N/A
	Road X Slope (%)	5.5	N/A	Clear Space to XWalk (in)	N/A
N/A	Any Obstructions?	N/A	N/A	Storm Grate/Utility Hazard?	N/A
	Obstruction Type			Storm Grate/Utility Type	
		N/A			N/A
		Yes		Surface Condition? (G/P)	Good

Remove & Replace Curb Ramp With Two New Directional Ramps or Equivalent.
