Access Compliance Report

Public Rights-of-Way

(Curb Ramps)

Intersection ID: 45644	Main Street: W_5TH_ST	Cross Street: W_6TH_ST	Location: E
ADA ID: 672142B1BEC1	Ramp Type: Perp	Initial Pass/Fail: Fail	Overall Compliance: No
Severity Score: 21.25			
Codes/Mitigation Info/Possible Solution		Field Measurements/Component Compliance

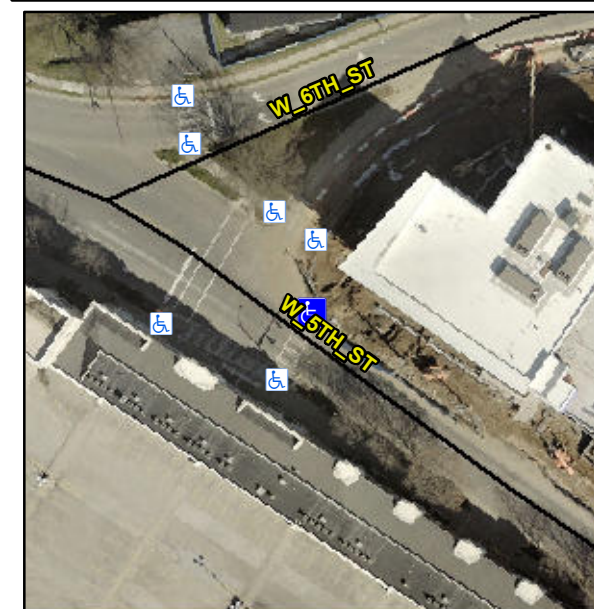
Not Found, R304.5.1, R304.5.3

Compliance	Description	Data	Compliance	Description	Data
N/A	Ramp Length (in)	73.0	Yes	Ramp Slope (%)	7.6
No	Ramp Width (in)	40.0	No	Ramp XSlope (%)	6.5
N/A	Flare Type LT	N/A	N/A	Flare Type RT	N/A
N/A	Flare Slope LT (%)	N/A	N/A	Flare Slope RT (%)	N/A
N/A	Flare Traversable LT?	N/A	N/A	Flare Traversable RT?	N/A
N/A	Landing Length (in)	N/A	N/A	DWS Provided?	N/A
N/A	Landing Width (in)	N/A	N/A	DWS Contrast?	N/A
N/A	Landing Slope (%)	N/A	N/A	DWS Length (in)	N/A
N/A	Landing X Slope (%)	N/A	N/A	DWS Full Width?	N/A
N/A	Landing Curb? (Y/N)	N/A	N/A	DWS Offset (in)	N/A
N/A	Shared Landing?	N/A			
N/A	Gutter Ponding?	N/A	N/A	Gutter Slope (%)	N/A
N/A	Gutter Lip Ht (in)	N/A	N/A	Gutter X Slope (%)	N/A
N/A	Painted X Walk1?	Yes	N/A	Painted X Walk2?	N/A
	X Walk 1 Direction	To SW		X Walk 2 Direction	N/A
N/A	X Walk 1 Width (in)	91.0	N/A	X Walk 2 Width (in)	N/A
	X Walk 1 Slope (%)	2.2		X Walk 2 Slope (%)	N/A
	X Walk 1 X Slope (%)	5.5		X Walk 2 X Slope (%)	N/A

Remove & Replace Entire Ramp.
