Access Compliance Report

Public Rights-of-Way

(Curb Ramps)

Intersection ID: 21011	Main Street: CORONATION_BV	Cross Street: SARDIS_RD_NORTH	Location: W
ADA ID: 673A6918E613	Ramp Type: Perp	Initial Pass/Fail: Fail	Overall Compliance: No
Severity Score: 61.25			
Codes/Mitigation Info/Possible Solution		Field Measurements/Component Compliance

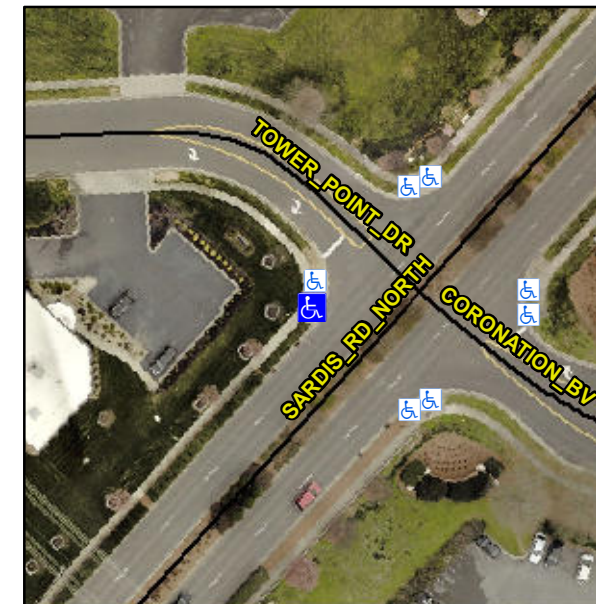
Not Found, R304.5.1, R304.2.2, R304.5.3, R302.7

Compliance	Description	Data	Compliance	Description	Data
N/A	Ramp Length (in)	62.0	No	Ramp Slope (%)	12.1
No	Ramp Width (in)	37.0	No	Ramp XSlope (%)	6.4
N/A	Flare Type LT	N/A	N/A	Flare Type RT	N/A
N/A	Flare Slope LT (%)	N/A	N/A	Flare Slope RT (%)	N/A
N/A	Flare Traversable LT?	N/A	N/A	Flare Traversable RT?	N/A
N/A	Landing Length (in)	N/A	N/A	DWS Provided?	N/A
N/A	Landing Width (in)	N/A	N/A	DWS Contrast?	N/A
N/A	Landing Slope (%)	N/A	N/A	DWS Length (in)	N/A
N/A	Landing X Slope (%)	N/A	N/A	DWS Full Width?	N/A
N/A	Landing Curb? (Y/N)	N/A	N/A	DWS Offset (in)	N/A
N/A	Shared Landing?	N/A			
N/A	Gutter Ponding?	N/A	N/A	Gutter Slope (%)	N/A
N/A	Gutter Lip Ht (in)	N/A	N/A	Gutter X Slope (%)	N/A
N/A	Painted X Walk1?	No	N/A	Painted X Walk2?	N/A
	X Walk 1 Direction	To SE		X Walk 2 Direction	N/A
N/A	X Walk 1 Width (in)	N/A	N/A	X Walk 2 Width (in)	N/A
	X Walk 1 Slope (%)	2.5		X Walk 2 Slope (%)	N/A
	X Walk 1 X Slope (%)	5.1		X Walk 2 X Slope (%)	N/A

N/A	Ramp inside XWalk1?	N/A	N/A	Ramp inside XWalk2?	N/A
	Road Slope (%)	N/A	N/A	Clear Space?	N/A
	Road X Slope (%)	N/A	N/A	Clear Space to XWalk (in)	N/A
N/A	Any Obstructions?	N/A	N/A	Storm Grate/Utility Hazard?	N/A
	Obstruction Type			Storm Grate/Utility Type	
		N/A			N/A
		No		Surface Condition? (G/P)	Poor

Remove & Replace Entire Ramp.
