# Access Compliance Report

## Public Rights-of-Way

### (Curb Ramps)

Intersection ID: 24097	Main Street: LIVINGSTON_MILL_RD	Cross Street: QUEENSWATER_LN	Location: NE
ADA ID: 673B6F941F4F	Ramp Type: Perp	Initial Pass/Fail: Fail	Overall Compliance: No
		Severity Score: 12.5

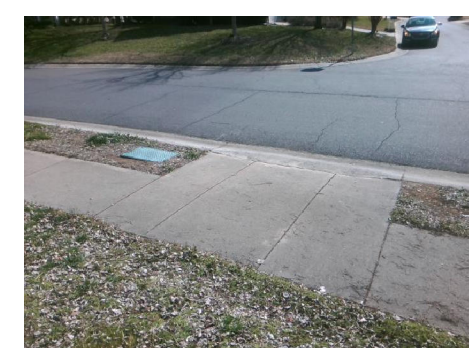
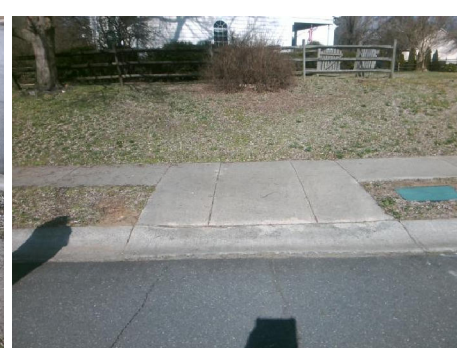
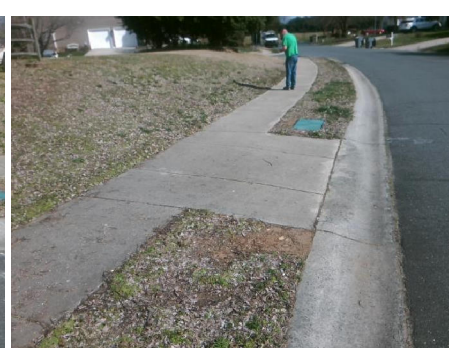
Possible Solutions:		<b>Compliance</b>	<b>Description</b>	<b>Data</b>
	Remove & Replace Entire Ramp.		N/A	Ramp Length (in)	48.0
			Yes	Ramp Width (in)	48.0
			N/A	Flare Type LT	N/A
			N/A	Flare Slope LT (%)	N/A
			N/A	Flare Traversable LT?	N/A
			N/A	Landing Length (in)	N/A
			N/A	Landing Width (in)	N/A
			N/A	Landing Slope (%)	N/A
			N/A	Landing X Slope (%)	N/A
<p>Surveyor Notes:</p> <p>N/A</p> <p>PROW/ADA:</p> <p>R304.2.2</p>			N/A	Flare Type RT	N/A
			N/A	Flare Slope RT (%)	N/A
			N/A	Flare Traversable RT?	N/A
			N/A	DWS Provided?	N/A
			N/A	DWS Contrast?	N/A
			N/A	DWS Length (in)	N/A
			N/A	DWS Full Width?	N/A
			N/A	DWS Offset (in)	N/A
			N/A	Shared Landing?	N/A
			N/A	Gutter Ponding?	N/A
			N/A	Gutter Lip Ht (in)	N/A
			N/A	Painted X Walk1?	No
				X Walk 1 Direction	To S
			N/A	X Walk 1 Width (in)	N/A
				X Walk 1 Slope (%)	3.8

X Walk 1 X Slope (%)	0.7
			N/A	Ramp inside XWalk1?	N/A
			N/A	Road Slope (%)	N/A
			N/A	Road X Slope (%)	N/A
			N/A	Any Obstructions?	N/A
				Obstruction Type	
Total Cost:		\$ 1850.00			
			N/A		
			Yes	Surface Condition? (G/P)	Good
