# Access Compliance Report

## Public Rights-of-Way

### (Curb Ramps)

Intersection ID: 43114	Main Street: HAMORTON_PL	Cross Street: THE_PLAZA	Location: SE
ADA ID: 673B8855D9E0	Ramp Type: Perp	Initial Pass/Fail: Fail	Overall Compliance: No
		Severity Score: 25

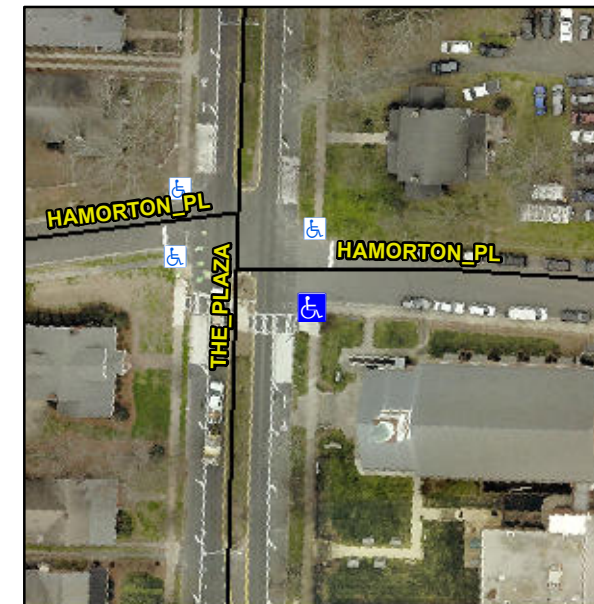
**R304.5.3**

Compliance	Description	Data	Compliance	Description	Data
N/A	Ramp Length (in)	44.0	Yes	Ramp Slope (%)	6.4
Yes	Ramp Width (in)	50.0	No	Ramp XSlope (%)	8.5
N/A	Flare Type LT	N/A	N/A	Flare Type RT	N/A
N/A	Flare Slope LT (%)	N/A	N/A	Flare Slope RT (%)	N/A
N/A	Flare Traversable LT?	N/A	N/A	Flare Traversable RT?	N/A
N/A	Landing Length (in)	N/A	N/A	DWS Provided?	N/A
N/A	Landing Width (in)	N/A	N/A	DWS Contrast?	N/A
N/A	Landing Slope (%)	N/A	N/A	DWS Length (in)	N/A
N/A	Landing X Slope (%)	N/A	N/A	DWS Full Width?	N/A
N/A	Landing Curb? (Y/N)	N/A	N/A	DWS Offset (in)	N/A
N/A	Shared Landing?	N/A			
N/A	Gutter Ponding?	N/A	N/A	Gutter Slope (%)	N/A
N/A	Gutter Lip Ht (in)	N/A	N/A	Gutter X Slope (%)	N/A
N/A	Painted X Walk1?	No	N/A	Painted X Walk2?	N/A
	X Walk 1 Direction	To N		X Walk 2 Direction	N/A
N/A	X Walk 1 Width (in)	N/A	N/A	X Walk 2 Width (in)	N/A
	X Walk 1 Slope (%)	4.4		X Walk 2 Slope (%)	N/A
	X Walk 1 X Slope (%)	0.1		X Walk 2 X Slope (%)	N/A

N/A	Ramp inside XWalk1?	N/A	N/A	Ramp inside XWalk2?	N/A
	Road Slope (%)	N/A	N/A	Clear Space?	N/A
	Road X Slope (%)	N/A	N/A	Clear Space to XWalk (in)	N/A
N/A	Any Obstructions?	N/A	N/A	Storm Grate/Utility Hazard?	N/A
	Obstruction Type			Storm Grate/Utility Type	
		N/A			N/A
			Yes	Surface Condition? (G/P)	Good

**Remove & Replace Entire Ramp.**

**\$ 1850.00**
