Access Compliance Report

Public Rights-of-Way

(Curb Ramps)

Intersection ID: 10022636	Main Street: CARMEL_RD	Cross Street: N/A	Location: SE
ADA ID: 6740D58D50D7	Ramp Type: PerpDiag	Initial Pass/Fail: Fail	Overall Compliance: No
Severity Score: 21.25			
Codes/Mitigation Info/Possible Solution		Field Measurements/Component Compliance

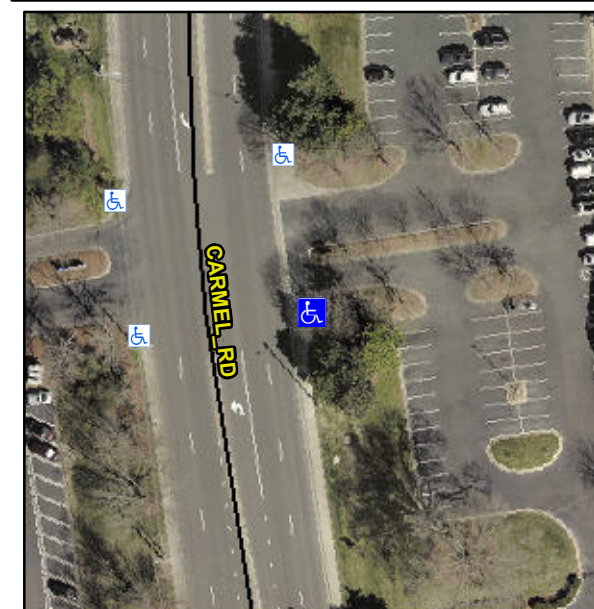
Not Found, R304.5.1, R304.2.2

Compliance	Description	Data	Compliance	Description	Data
N/A	Ramp Length (in)	59.5	No	Ramp Slope (%)	8.5
No	Ramp Width (in)	46.0	Yes	Ramp XSlope (%)	1.8
N/A	Flare Type LT	N/A	N/A	Flare Type RT	N/A
N/A	Flare Slope LT (%)	N/A	N/A	Flare Slope RT (%)	N/A
N/A	Flare Traversable LT?	N/A	N/A	Flare Traversable RT?	N/A
N/A	Landing Length (in)	N/A	N/A	DWS Provided?	N/A
N/A	Landing Width (in)	N/A	N/A	DWS Contrast?	N/A
N/A	Landing Slope (%)	N/A	N/A	DWS Length (in)	N/A
N/A	Landing X Slope (%)	N/A	N/A	DWS Full Width?	N/A
N/A	Landing Curb? (Y/N)	N/A	N/A	DWS Offset (in)	N/A
N/A	Shared Landing?	N/A			
N/A	Gutter Ponding?	N/A	N/A	Gutter Slope (%)	N/A
N/A	Gutter Lip Ht (in)	N/A	N/A	Gutter X Slope (%)	N/A
N/A	Painted X Walk1?	No	N/A	Painted X Walk2?	No
	X Walk 1 Direction	To N		X Walk 2 Direction	To W
N/A	X Walk 1 Width (in)	N/A	N/A	X Walk 2 Width (in)	N/A
	X Walk 1 Slope (%)	1.0		X Walk 2 Slope (%)	0.9
	X Walk 1 X Slope (%)	5.2		X Walk 2 X Slope (%)	1.1

N/A	Ramp inside XWalk1?	N/A	N/A	Ramp inside XWalk2?	N/A
	Road Slope (%)	4.6	N/A	Clear Space?	N/A
	Road X Slope (%)	3.9	N/A	Clear Space to XWalk (in)	N/A
N/A	Any Obstructions?	N/A	N/A	Storm Grate/Utility Hazard?	N/A
	Obstruction Type			Storm Grate/Utility Type	
		N/A			N/A
		Yes		Surface Condition? (G/P)	Good

Possible Solutions:

Remove & Replace Curb Ramp With Two New Directional Ramps or Equivalent.
