## Access Compliance Report Public Rights-of-Way (Curb Ramps)

Intersection ID: 5854	Main Street: COMFREY_CT			Street.	PARTRIDGEBERRY_D	Location:	NE			
ADA ID: 6743450CEF4B Ramp Type: Perp			Initial Pass/Fail: Fail Overall Compliance: No					12.5		
Codes/Mitigation Info/Possible Solution				Field Measurements/Component Compliance						
State State State	WE SAL	Possible Solutions:	Compliance Description			Data	Data Compliance Description			
	Jak 1	Remove & Replace Entire Ramp		N/A	Ramp Length (in)	47.5	No	Ramp Slope (%)	10.3	
				Yes	Ramp Width (in)	89.5	Yes	Ramp XSlope (%)	0.3	
	The second			N/A	Flare Type LT	N/A	N/A	Flare Type RT	N/A

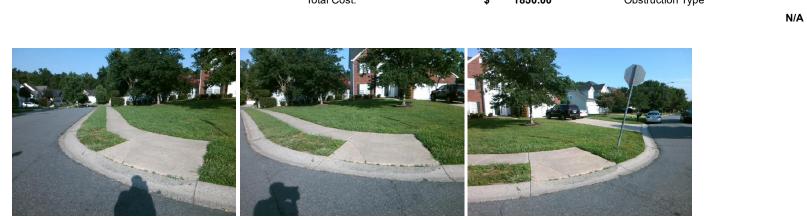
1.6-11-2-			N/A	Flare Slope LT (%)	N/A	N/A	Flare Slope RT (%)	N/A	
		1		N/A	Flare Traversable LT?	N/A	N/A	Flare Traversable RT?	N/A	
	10/1			N/A	Landing Length (in)	N/A	N/A	DWS Provided?	N/A	
	0	Surveyor Notes:		N/A	Landing Width (in)	N/A	N/A	DWS Contrast?	N/A	
the second se	Pour	N/A		N/A	Landing Slope (%)	N/A	N/A	DWS Length (in)	N/A	
The Caller	ALL THE DE			N/A	Landing X Slope (%)	N/A	N/A	DWS Full Width?	N/A	
CALSULUS .	1 14 1			N/A	Landing Curb? (Y/N)	N/A	N/A	DWS Offset (in)	N/A	
	12 NO			N/A	Shared Landing?	N/A				
	APL I	PROW/ADA:		N/A	Gutter Ponding?	N/A	N/A	Gutter Slope (%)	N/A	
and the second	10 20	Not Found, R304.2.2		N/A	Gutter Lip Ht (in)	N/A	N/A	Gutter X Slope (%)	N/A

C. The martine			N/A	Painted X Walk1?	No	N/A	Painted X Walk2?	N/A	
the state of the second	T 2 Martin				X Walk 1 Direction	To W		X Walk 2 Direction	N/A	
				N/A	X Walk 1 Width (in)	N/A	N/A	X Walk 2 Width (in)	N/A	
Street 1 Name	COMFREY CT				X Walk 1 Slope (%)	3.7		X Walk 2 Slope (%)	N/A	
Stop Condition-Street 2	StopSign				X Walk 1 X Slope (%)	5.1		X Walk 2 X Slope (%)	N/A	
Street 2 Name	N/A			N/A	Ramp inside XWalk1?	N/A	N/A	Ramp inside XWalk2?	N/A	
Stop Condition-Street 1	N/A				Road Slope (%)	N/A	N/A	Clear Space?	N/A	
					Road X Slope (%)	N/A	N/A	Clear Space to XWalk (in)	N/A	
				N/A	Any Obstructions?	N/A	N/A	Storm Grate/Utility Hazard?	N/A	
		Total Cost: \$	1850.00		Obstruction Type			Storm Grate/Utility Type		
						N/A			N/A
