# Access Compliance Report

## Public Rights-of-Way

### (Curb Ramps)

Intersection ID: N/A	Main Street: TAMARACK DR	Cross Street: SINGLELEAF LN	Location: SW
ADA ID: 675B6449966C	Ramp Type: Perp	Initial Pass/Fail: Fail	Overall Compliance: No
		Severity Score: 12.5

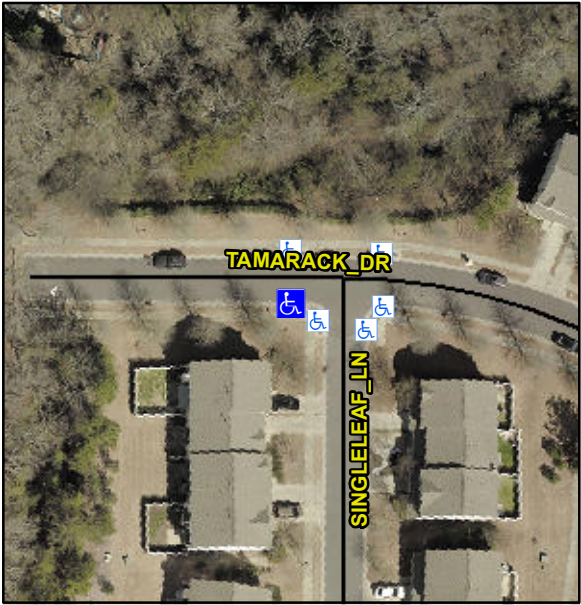
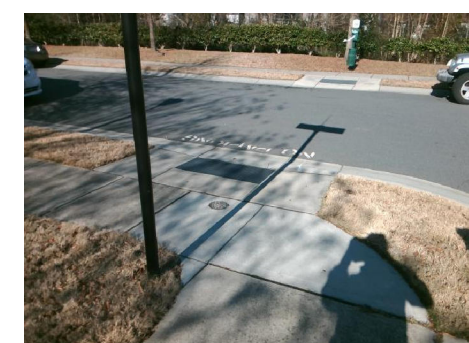
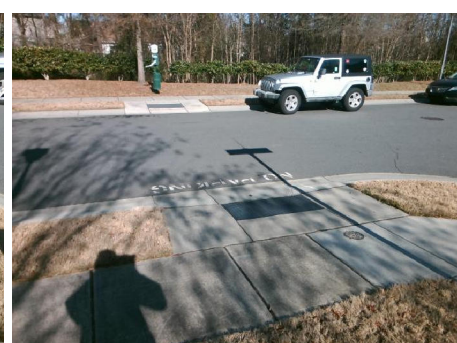
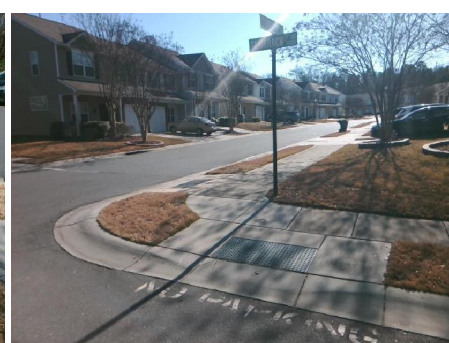
Possible Solutions:		<b>Compliance</b>	<b>Description</b>	<b>Data</b>
	Remove & Replace Entire Ramp.		N/A	Ramp Length (in)	46.5
			Yes	Ramp Width (in)	48.0
			N/A	Flare Type LT	N/A
			N/A	Flare Slope LT (%)	N/A
			N/A	Flare Traversable LT?	No
			N/A	Landing Length (in)	N/A
			N/A	Landing Width (in)	N/A
			N/A	Landing Slope (%)	N/A
			N/A	Landing X Slope (%)	N/A
<p>Surveyor Notes:</p> <p>N/A</p> <p>PROW/ADA:</p> <p>Not Found, R304.2.2</p>			N/A	Flare Type RT	N/A
			N/A	Flare Slope RT (%)	N/A
			N/A	Flare Traversable RT?	No
			N/A	DWS Provided?	N/A
			N/A	DWS Contrast?	N/A
			N/A	DWS Length (in)	N/A
			N/A	DWS Full Width?	N/A
			N/A	DWS Offset (in)	N/A
			N/A	Gutter Ponding?	N/A
			N/A	Gutter Lip Ht (in)	N/A
			N/A	Painted X Walk1?	No
				X Walk 1 Direction	To N
			N/A	X Walk 1 Width (in)	N/A
				X Walk 1 Slope (%)	2.5
				X Walk 1 X Slope (%)	1.3

N/A	Ramp inside XWalk1?	No
				Road Slope (%)	N/A
				Road X Slope (%)	N/A
			N/A	Any Obstructions?	N/A
				Obstruction Type	
Total Cost: \$ 1850.00			N/A	Storm Grate/Utility Hazard?	N/A
				Storm Grate/Utility Type	
			N/A		N/A
			Yes	Surface Condition? (G/P)	Good
