# Access Compliance Report

## Public Rights-of-Way

Intersection ID: 30054	Main Street: DAY_LILLY_LN	Cross Street: SOUTHWIND_DR	Location: S
ADA ID: 67776BF7403A	Ramp Type: PerpDiag	Initial Pass/Fail: Fail	Overall Compliance: No
Severity Score: 10			
Codes/Mitigation Info/Possible Solution		Field Measurements/Component Compliance

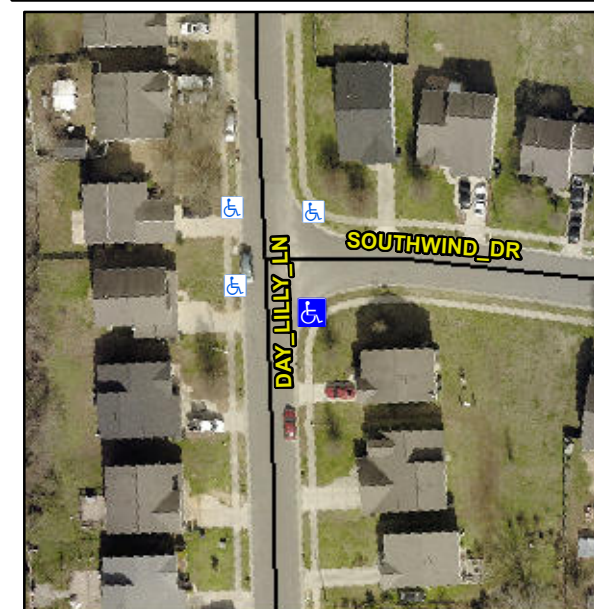
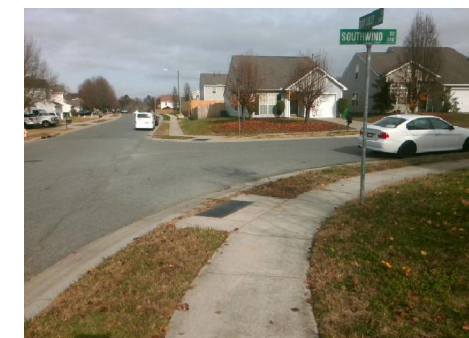
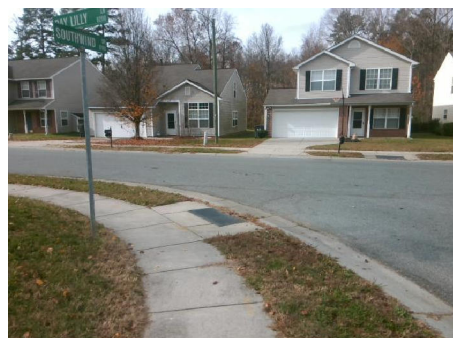
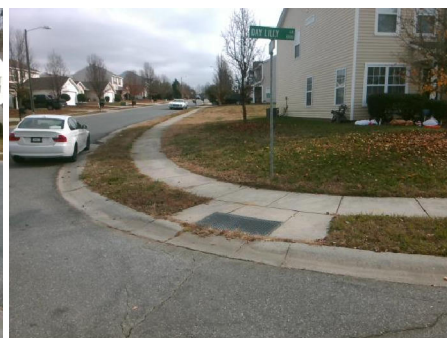
**Not Found, R304.5.1, R304.5.3**

Compliance	Description	Data	Compliance	Description	Data
N/A	Ramp Length (in)	51.0	Yes	Ramp Slope (%)	6.1
No	Ramp Width (in)	42.0	No	Ramp XSlope (%)	2.5
N/A	Flare Type LT	N/A	N/A	Flare Type RT	N/A
N/A	Flare Slope LT (%)	N/A	N/A	Flare Slope RT (%)	N/A
N/A	Flare Traversable LT?	N/A	N/A	Flare Traversable RT?	N/A
N/A	Landing Length (in)	N/A	N/A	DWS Provided?	N/A
N/A	Landing Width (in)	N/A	N/A	DWS Contrast?	N/A
N/A	Landing Slope (%)	N/A	N/A	DWS Length (in)	N/A
N/A	Landing X Slope (%)	N/A	N/A	DWS Full Width?	N/A
N/A	Landing Curb? (Y/N)	N/A	N/A	DWS Offset (in)	N/A
N/A	Shared Landing?	N/A			
N/A	Gutter Ponding?	N/A	N/A	Gutter Slope (%)	N/A
N/A	Gutter Lip Ht (in)	N/A	N/A	Gutter X Slope (%)	N/A
N/A	Painted X Walk1?	No	N/A	Painted X Walk2?	No
	X Walk 1 Direction	To N		X Walk 2 Direction	To NW
N/A	X Walk 1 Width (in)	N/A	N/A	X Walk 2 Width (in)	N/A
	X Walk 1 Slope (%)	0.0		X Walk 2 Slope (%)	1.4
	X Walk 1 X Slope (%)	2.8		X Walk 2 X Slope (%)	2.2

N/A	Ramp inside XWalk1?	N/A	N/A	Ramp inside XWalk2?	N/A
	Road Slope (%)	0.8	N/A	Clear Space?	N/A
	Road X Slope (%)	0.0	N/A	Clear Space to XWalk (in)	N/A
N/A	Any Obstructions?	N/A	N/A	Storm Grate/Utility Hazard?	N/A
	Obstruction Type			Storm Grate/Utility Type	
		N/A			N/A
		Yes		Surface Condition? (G/P)	Good

**Remove & Replace Curb Ramp With Two New Directional Ramps or Equivalent.**
