# Access Compliance Report

## Public Rights-of-Way

### (Curb Ramps)

Intersection ID: 46203	Main Street: LOROPETALUM_RD	Cross Street: IMPATIEN_DR	Location: SE
ADA ID: 6781131E0873	Ramp Type: PerpDiag	Initial Pass/Fail: Fail	Overall Compliance: No
Severity Score: 8.75			
Codes/Mitigation Info/Possible Solution		Field Measurements/Component Compliance

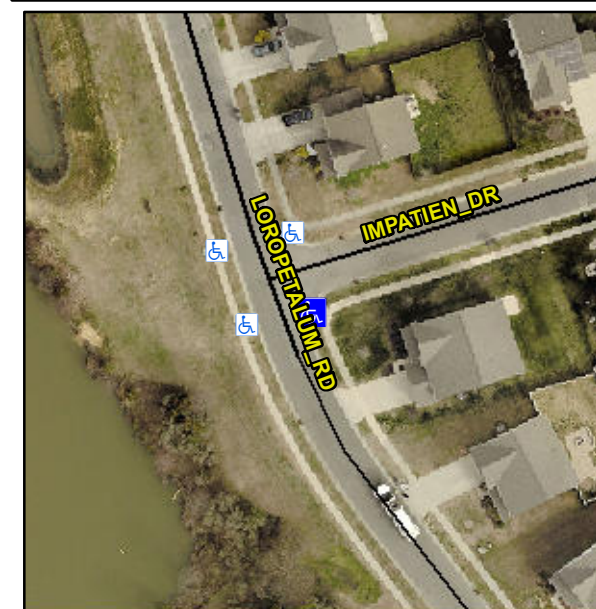
**Not Found, R304.5.1**

Compliance	Description	Data	Compliance	Description	Data
N/A	Ramp Length (in)	70.0	Yes	Ramp Slope (%)	6.9
No	Ramp Width (in)	47.0	Yes	Ramp XSlope (%)	1.3
N/A	Flare Type LT	N/A	N/A	Flare Type RT	N/A
N/A	Flare Slope LT (%)	N/A	N/A	Flare Slope RT (%)	N/A
N/A	Flare Traversable LT?	N/A	N/A	Flare Traversable RT?	N/A
N/A	Landing Length (in)	N/A	N/A	DWS Provided?	N/A
N/A	Landing Width (in)	N/A	N/A	DWS Contrast?	N/A
N/A	Landing Slope (%)	N/A	N/A	DWS Length (in)	N/A
N/A	Landing X Slope (%)	N/A	N/A	DWS Full Width?	N/A
N/A	Landing Curb? (Y/N)	N/A	N/A	DWS Offset (in)	N/A
N/A	Shared Landing?	N/A			
N/A	Gutter Ponding?	N/A	N/A	Gutter Slope (%)	N/A
N/A	Gutter Lip Ht (in)	1.0	N/A	Gutter X Slope (%)	N/A
N/A	Painted X Walk1?	No	N/A	Painted X Walk2?	No
	X Walk 1 Direction	To N		X Walk 2 Direction	To W
N/A	X Walk 1 Width (in)	N/A	N/A	X Walk 2 Width (in)	N/A
	X Walk 1 Slope (%)	0.4		X Walk 2 Slope (%)	1.9
	X Walk 1 X Slope (%)	0.3		X Walk 2 X Slope (%)	0.7

**Remove & Replace Curb Ramp With Two New Directional Ramps or Equivalent.**

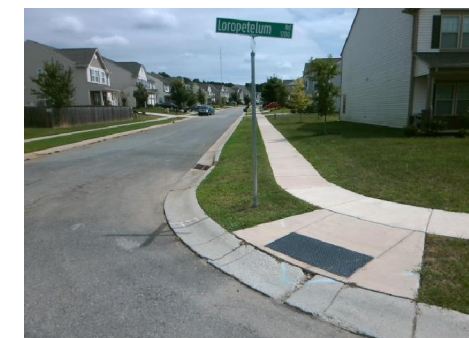
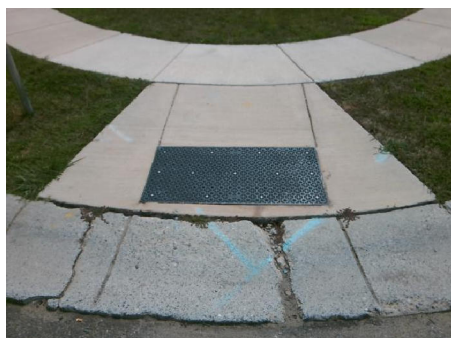
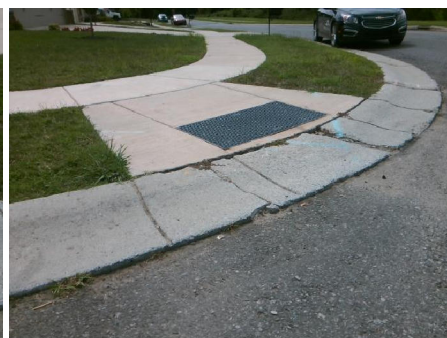
N/A	Ramp inside XWalk1?	N/A	N/A	Ramp inside XWalk2?	N/A
	Road Slope (%)	1.1	N/A	Clear Space?	N/A
	Road X Slope (%)	1.3	N/A	Clear Space to XWalk (in)	N/A
N/A	Any Obstructions?	N/A	N/A	Storm Grate/Utility Hazard?	N/A
	Obstruction Type			Storm Grate/Utility Type	
		N/A			N/A
		Yes		Surface Condition? (G/P)	Good

Street 1 Name IMPATIEN DR  
 Stop Condition-Street 2 StopSign  
 Street 2 Name LOROPETALUM RD  
 Stop Condition-Street 1 None
