# Access Compliance Report

## Public Rights-of-Way

### (Curb Ramps)

Intersection ID: 46306	Main Street: BECKET RIDGE RD	Cross Street: AUGUSTINE_WY	Location: NW
ADA ID: 67913826A32B	Ramp Type: PerpDiag	Initial Pass/Fail: Fail	Overall Compliance: No
		Severity Score: 22.5

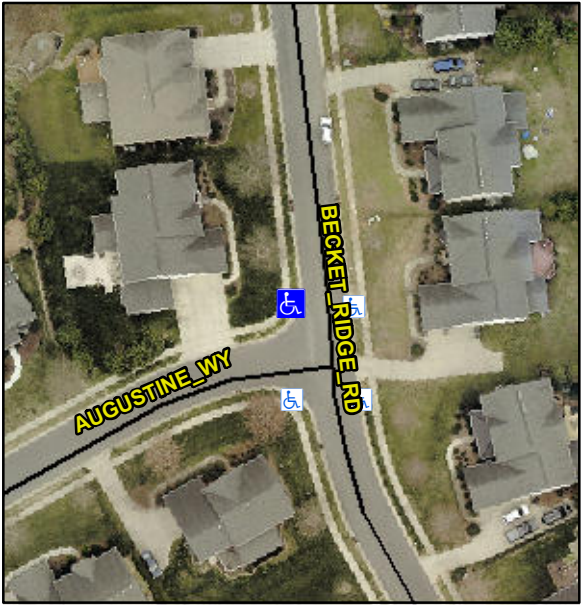
Possible Solutions:		<b>Compliance</b>	<b>Description</b>	<b>Data</b>
	<b>Remove &amp; Replace Curb Ramp With Two New Directional Ramps or Equivalent.</b>		<b>No</b>	Ramp Length (in)	<b>46.0</b>
			<b>No</b>	Ramp Width (in)	<b>43.0</b>
			<b>N/A</b>	Flare Type LT	<b>N/A</b>
			<b>N/A</b>	Flare Slope LT (%)	<b>N/A</b>
			<b>N/A</b>	Flare Traversable LT?	<b>N/A</b>
			<b>N/A</b>	Landing Length (in)	<b>N/A</b>
			<b>N/A</b>	Landing Width (in)	<b>N/A</b>
			<b>N/A</b>	Landing Slope (%)	<b>N/A</b>
			<b>N/A</b>	Landing X Slope (%)	<b>N/A</b>
<p>Surveyor Notes:</p> <p><b>N/A</b></p> <p>PROW/ADA:</p> <p><b>Not Found, R304.5.1, R304.2.2, R304.5.3</b></p>			<b>N/A</b>	Flare Type RT	<b>N/A</b>
			<b>N/A</b>	Flare Slope RT (%)	<b>N/A</b>
			<b>N/A</b>	Flare Traversable RT?	<b>N/A</b>
			<b>N/A</b>	DWS Provided?	<b>N/A</b>
			<b>N/A</b>	DWS Contrast?	<b>N/A</b>

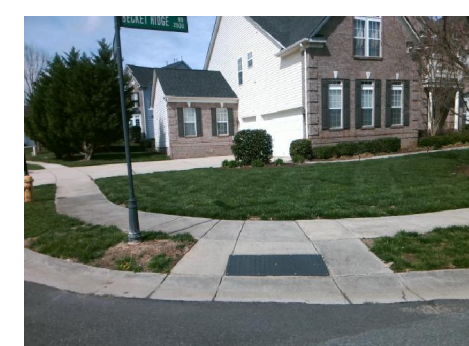
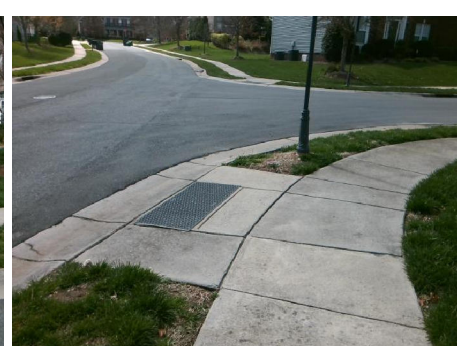
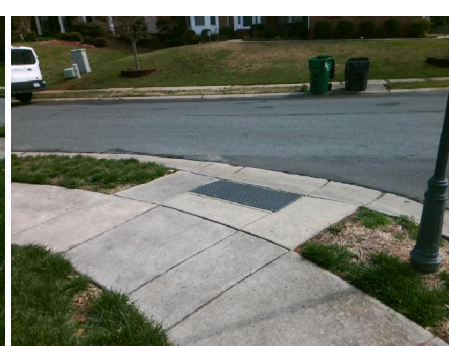
<b>N/A</b>	DWS Length (in)	<b>N/A</b>
			<b>N/A</b>	DWS Full Width?	<b>N/A</b>
			<b>N/A</b>	DWS Offset (in)	<b>N/A</b>
			<b>N/A</b>	Gutter Ponding?	<b>N/A</b>
			<b>N/A</b>	Gutter Lip Ht (in)	<b>N/A</b>
<p>Street 1 Name <b>AUGUSTINE WY</b></p> <p>Stop Condition-Street 2 <b>StopSign</b></p> <p>Street 2 Name <b>BECKET RIDGE RD</b></p> <p>Stop Condition-Street 1 <b>None</b></p>			<b>No</b>	Painted X Walk1?	<b>No</b>
				X Walk 1 Direction	<b>To S</b>
			<b>N/A</b>	X Walk 1 Width (in)	<b>N/A</b>
				X Walk 1 Slope (%)	<b>2.5</b>
				X Walk 1 X Slope (%)	<b>1.4</b>
			<b>N/A</b>	Ramp inside XWalk1?	<b>N/A</b>
				Road Slope (%)	<b>3.6</b>
				Road X Slope (%)	<b>2.5</b>
			<b>N/A</b>	Any Obstructions?	<b>N/A</b>
				Obstruction Type	
Total Cost:		<b>\$ 3200.00</b>			
			<b>N/A</b>	Storm Grate/Utility Hazard?	<b>N/A</b>
				Storm Grate/Utility Type	
			<b>N/A</b>		<b>N/A</b>
			<b>Yes</b>	Surface Condition? (G/P)	<b>Good</b>
