Access Compliance Report

Public Rights-of-Way

(Curb Ramps)

| Intersection ID: 15450 | Main Street: ALBEMARLE_RD | Cross Street: PIERSON_DR | Location: NE |

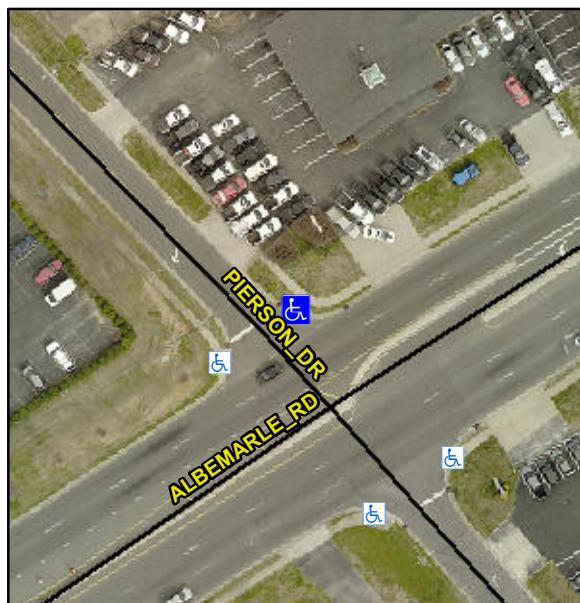
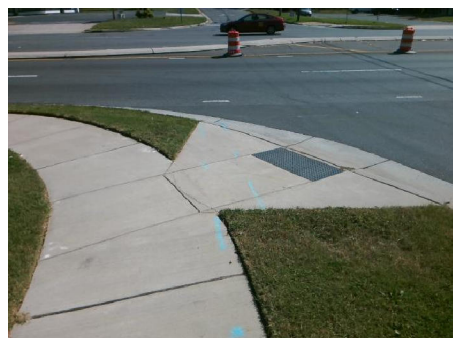
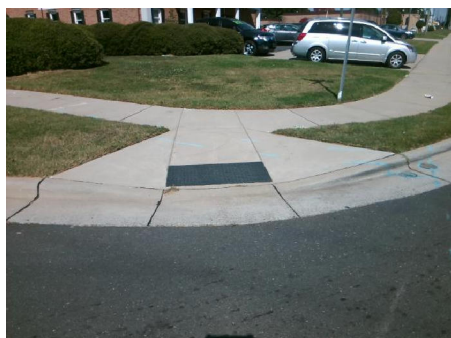
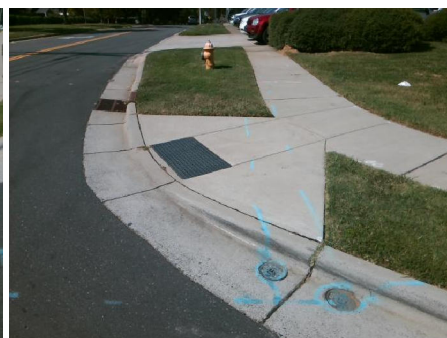
Not Found, R304.5.1

| Compliance | Description | Data | Compliance | Description | Data |
|---|---|---|---|---|---|
| N/A | Ramp Length (in) | 82.0 | Yes | Ramp Slope (%) | 6.4 |
| No | Ramp Width (in) | 43.0 | Yes | Ramp XSlope (%) | 1.8 |
| | | | Yes | Surface Condition? (G/P) | Good |

Possible Solutions:

Remove & Replace Entire Ramp.

Total Cost: \$ 1850.00
