# Access Compliance Report

## Public Rights-of-Way

### (Curb Ramps)

| Intersection ID: 22098 | Main Street: CAMBRIDGE CRESCENT DR | Cross Street: OXFORD CRESCENT CT | Location: S |

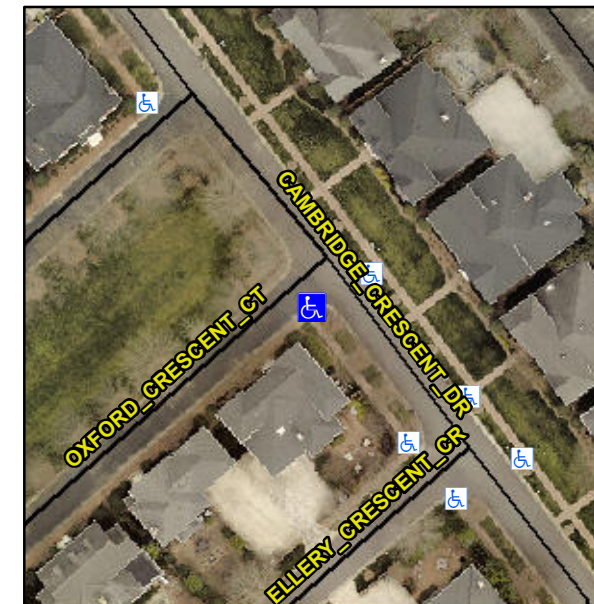
| ADA ID: 67B18F839055 | Ramp Type: PerpDiag | Initial Pass/Fail: Fail | Overall Compliance: No |
| Severity Score: 22.5 | | | |

**Not Found, R304.5.1, R304.2.2, R304.5.3**

| Compliance | Description | Data | Compliance | Description | Data |
|---|---|---|---|---|---|
| N/A | Ramp Length (in) | 46.0 | No | Ramp Slope (%) | 10.5 |
| No | Ramp Width (in) | 43.0 | No | Ramp XSlope (%) | 2.5 |

**Remove & Replace Curb Ramp With Two New Directional Ramps or Equivalent.**

Total Cost: \$ 3200.00
