Access Compliance Report

Public Rights-of-Way

(Curb Ramps)

Intersection ID: 30087	Main Street: DEVONBRIDGE_LN	Cross Street: DEVONHILL_LN	Location:	N
ADA ID: 67DCA8F96371	Ramp Type: PerpDiag	Initial Pass/Fail: Fail	Overall Compliance: No	Severity Score: 33.75
Codes/Mitigation Info/Possible Solution		Field Measurements/Component Compliance

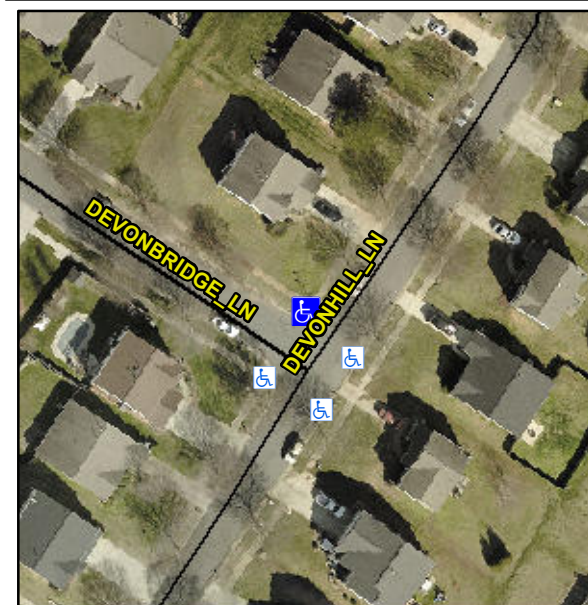
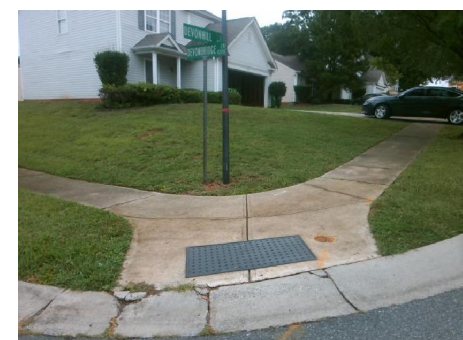
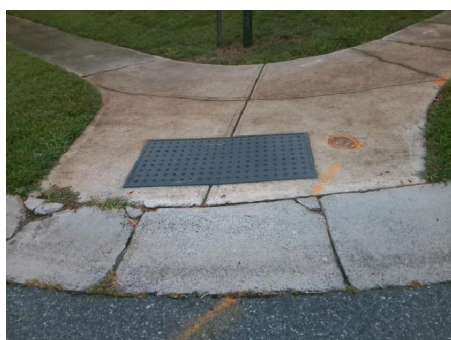
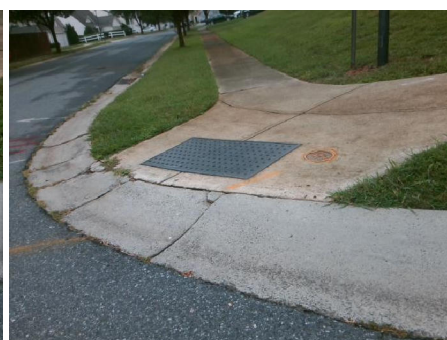
Not Found, R304.5.1, R304.5.3

Compliance	Description	Data	Compliance	Description	Data
N/A	Ramp Length (in)	59.0	Yes	Ramp Slope (%)	6.8
No	Ramp Width (in)	40.0	No	Ramp XSlope (%)	8.6
N/A	Flare Type LT	N/A	N/A	Flare Type RT	N/A
N/A	Flare Slope LT (%)	N/A	N/A	Flare Slope RT (%)	N/A
N/A	Flare Traversable LT?	N/A	N/A	Flare Traversable RT?	N/A
N/A	Landing Length (in)	N/A	N/A	DWS Provided?	N/A
N/A	Landing Width (in)	N/A	N/A	DWS Contrast?	N/A
N/A	Landing Slope (%)	N/A	N/A	DWS Length (in)	N/A
N/A	Landing X Slope (%)	N/A	N/A	DWS Full Width?	N/A
N/A	Landing Curb? (Y/N)	N/A	N/A	DWS Offset (in)	N/A
N/A	Shared Landing?	N/A			
N/A	Gutter Ponding?	N/A	N/A	Gutter Slope (%)	N/A
N/A	Gutter Lip Ht (in)	N/A	N/A	Gutter X Slope (%)	N/A
N/A	Painted X Walk1?	No	N/A	Painted X Walk2?	No
	X Walk 1 Direction	To SW		X Walk 2 Direction	To SE
N/A	X Walk 1 Width (in)	N/A	N/A	X Walk 2 Width (in)	N/A
	X Walk 1 Slope (%)	0.9		X Walk 2 Slope (%)	6.4
	X Walk 1 X Slope (%)	4.2		X Walk 2 X Slope (%)	4.3

N/A	Ramp inside XWalk1?	N/A	N/A	Ramp inside XWalk2?	N/A
	Road Slope (%)	6.3	N/A	Clear Space?	N/A
	Road X Slope (%)	0.3	N/A	Clear Space to XWalk (in)	N/A
N/A	Any Obstructions?	N/A	N/A	Storm Grate/Utility Hazard?	N/A
	Obstruction Type			Storm Grate/Utility Type	
		N/A			N/A
			Yes	Surface Condition? (G/P)	Good

Possible Solutions:

Remove & Replace Curb Ramp With Two New Directional Ramps or Equivalent.
