Access Compliance Report Public Rights-of-Way (Curb Ramps)

Intersection ID: 50631 Main Street: CORAL_ROSE_RD			Cross	Street:	RUBY_VALLEY_RD	Location:	SE			
ADA ID: 67EE6098763E	ID: 67EE6098763E Ramp Type: Perp			Initial	Pass/Fa	ail: Fail Overall	o Severity Score:	22.5		
Codes/Mitigation Info/Possible Solution					Field Measurements/Component Compliance					
	The seal of the	Possible Solutions:			Compliance Description			Data Compliance Description

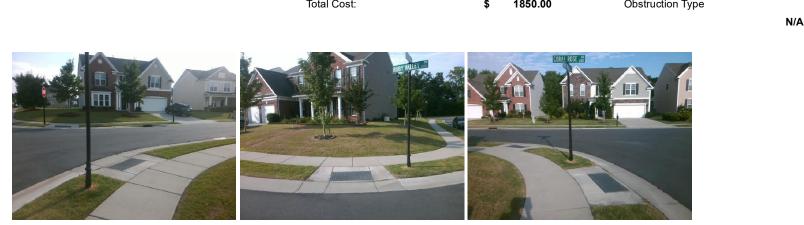
- Marine Marine	Remove & Rep	lace Entire Ram	D.	N/A	Ramp Length (in)	46.0	No	Ramp Slope (%)	8.6
				P .	No	Ramp Width (in)	47.0	No	Ramp XSlope (%)	2.1
	A A				N/A	Flare Type LT	N/A	N/A	Flare Type RT	N/A
