# Access Compliance Report

## Public Rights-of-Way

### (Curb Ramps)

| Intersection ID: N/A | Main Street: NATIONS_FORD_RD | Cross Street: N/A | Location: SW |

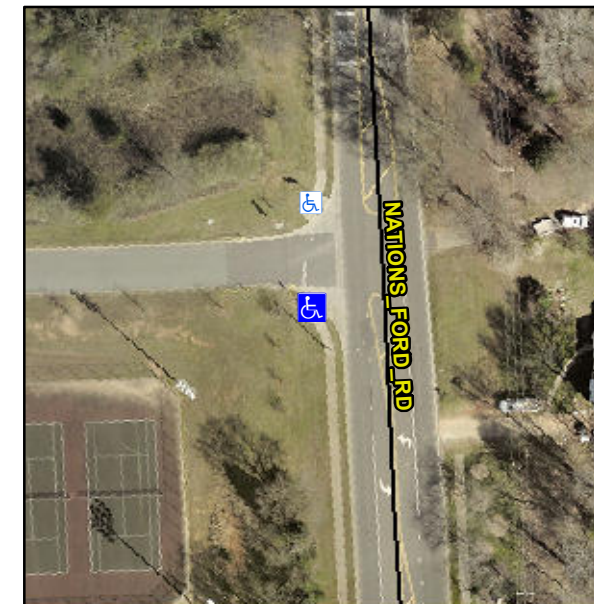
| ADA ID: 67F3ACFA6FDC | Ramp Type: PerpDiag | Initial Pass/Fail: Fail | Overall Compliance: No |
| Severity Score: 10 | | | |

**Not Found, R304.5.1, R304.5.3**

| Compliance | Description | Data | Compliance | Description | Data |
|---|---|---|---|---|---|
| N/A | Ramp Length (in) | 107.0 | Yes | Ramp Slope (%) | 6.0 |
| No | Ramp Width (in) | 47.0 | No | Ramp XSlope (%) | 2.1 |

**Remove & Replace Curb Ramp With Two New Directional Ramps or Equivalent.**

Total Cost: \$ 3200.00
