# Access Compliance Report

## Public Rights-of-Way

### (Curb Ramps)

Intersection ID: 15833	Main Street: SOUTH_BV	Cross Street: CLANTON_RD	Location: SE
ADA ID: 67F483FAD14E	Ramp Type: Perp	Initial Pass/Fail: Fail	Overall Compliance: No
Severity Score: 8.75			
Codes/Mitigation Info/Possible Solution		Field Measurements/Component Compliance

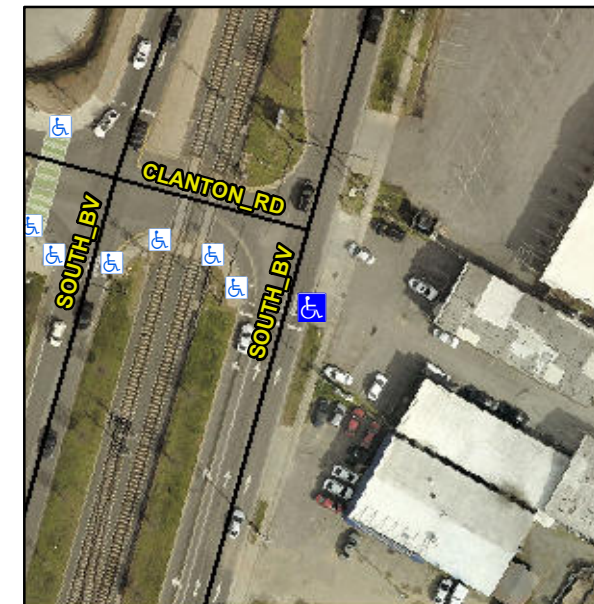
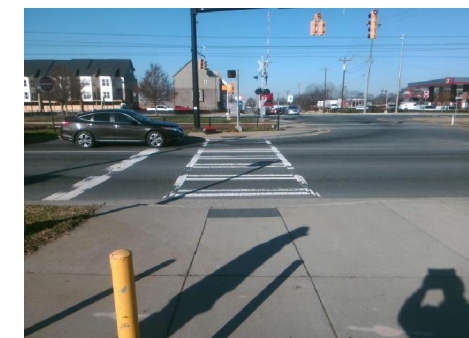
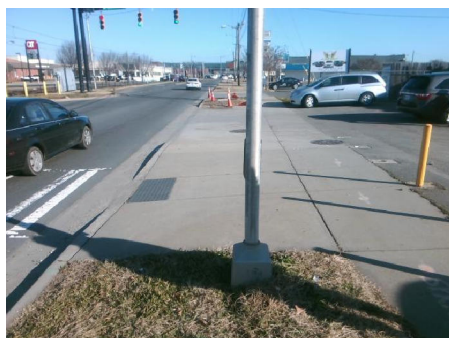
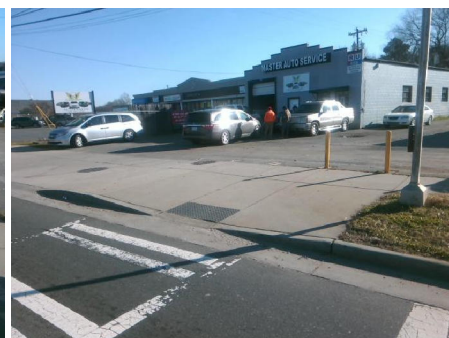
**Not Found, R304.5.1**

Compliance	Description	Data	Compliance	Description	Data
N/A	Ramp Length (in)	110.0	Yes	Ramp Slope (%)	5.4
No	Ramp Width (in)	47.0	Yes	Ramp XSlope (%)	0.8
N/A	Flare Type LT	N/A	N/A	Flare Type RT	N/A
N/A	Flare Slope LT (%)	N/A	N/A	Flare Slope RT (%)	N/A
N/A	Flare Traversable LT?	N/A	N/A	Flare Traversable RT?	N/A
N/A	Landing Length (in)	N/A	N/A	DWS Provided?	N/A
N/A	Landing Width (in)	N/A	N/A	DWS Contrast?	N/A
N/A	Landing Slope (%)	N/A	N/A	DWS Length (in)	N/A
N/A	Landing X Slope (%)	N/A	N/A	DWS Full Width?	N/A
N/A	Landing Curb? (Y/N)	N/A	N/A	DWS Offset (in)	N/A
N/A	Shared Landing?	N/A			
N/A	Gutter Ponding?	N/A	N/A	Gutter Slope (%)	N/A
N/A	Gutter Lip Ht (in)	N/A	N/A	Gutter X Slope (%)	N/A
N/A	Painted X Walk1?	Yes	N/A	Painted X Walk2?	N/A
	X Walk 1 Direction	To NW		X Walk 2 Direction	N/A
N/A	X Walk 1 Width (in)	112.0	N/A	X Walk 2 Width (in)	N/A
	X Walk 1 Slope (%)	0.4		X Walk 2 Slope (%)	N/A
	X Walk 1 X Slope (%)	0.3		X Walk 2 X Slope (%)	N/A

N/A	Ramp inside XWalk1?	Yes	N/A	Ramp inside XWalk2?	N/A
	Road Slope (%)	N/A	N/A	Clear Space?	N/A
	Road X Slope (%)	N/A	N/A	Clear Space to XWalk (in)	N/A
N/A	Any Obstructions?	N/A	N/A	Storm Grate/Utility Hazard?	N/A
	Obstruction Type			Storm Grate/Utility Type	
		N/A			N/A
		Yes		Surface Condition? (G/P)	Good

**Remove & Replace Entire Ramp.**

Total Cost: \$ 1850.00
