Access Compliance Report

Public Rights-of-Way

(Curb Ramps)

Intersection ID: 47920	Main Street: RINGNECK_RD	Cross Street: ROOK_RD	Location: SE
ADA ID: 6800076BE7B7	Ramp Type: PerpDiag	Initial Pass/Fail: Fail	Overall Compliance: No
Codes/Mitigation Info/Possible Solution		Field Measurements/Component Compliance

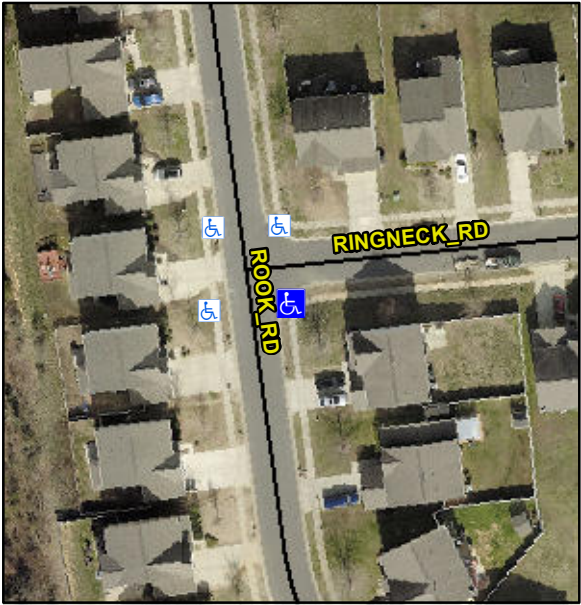
Possible Solutions:		Compliance	Description	Data	Compliance	Description	Data
	Remove & Replace Curb Ramp With Two New Directional Ramps or Equivalent.		N/A	Ramp Length (in)	49.5	No	Ramp Slope (%)	9.4
<p>Surveyor Notes:</p> <p>N/A</p> <p>PROW/ADA:</p> <p>R304.2.2, R304.5.3</p>			Yes	Ramp Width (in)	48.0	No	Ramp XSlope (%)	2.6
			N/A	Flare Type LT	N/A	N/A	Flare Type RT	N/A
<p>Street 1 Name</p> <p>Stop Condition-Street 2</p> <p>Street 2 Name</p> <p>Stop Condition-Street 1</p>			N/A	Flare Slope LT (%)	N/A	N/A	Flare Slope RT (%)	N/A
			N/A	Flare Traversable LT?	N/A	N/A	Flare Traversable RT?	N/A
<p>Total Cost:</p> <p>\$ 3200.00</p>			N/A	Landing Length (in)	N/A	N/A	DWS Provided?	N/A
			N/A	Landing Width (in)	N/A	N/A	DWS Contrast?	N/A
			N/A	Landing Slope (%)	N/A	N/A	DWS Length (in)	N/A
			N/A	Landing X Slope (%)	N/A	N/A	DWS Full Width?	N/A
			N/A	Landing Curb? (Y/N)	N/A	N/A	DWS Offset (in)	N/A
			N/A	Shared Landing?	N/A	N/A	Gutter Slope (%)	N/A

N/A	Gutter Ponding?	N/A	N/A	Gutter X Slope (%)	N/A
			N/A	Gutter Lip Ht (in)	N/A	N/A	Painted X Walk2?	No
			N/A	Painted X Walk1?	No	N/A	X Walk 2 Direction	To W
			N/A	X Walk 1 Direction	To N	N/A	X Walk 2 Width (in)	N/A
			N/A	X Walk 1 Width (in)	N/A	N/A	X Walk 2 Slope (%)	1.8
			N/A	X Walk 1 Slope (%)	4.0	N/A	X Walk 2 X Slope (%)	5.2
			N/A	X Walk 1 X Slope (%)	2.9	N/A	Ramp inside XWalk2?	N/A
			N/A	Ramp inside XWalk1?	N/A	N/A	Clear Space?	N/A
			N/A	Road Slope (%)	3.5	N/A	Clear Space to XWalk (in)	N/A
			N/A	Road X Slope (%)	5.2	N/A	Storm Grate/Utility Hazard?	N/A
			N/A	Any Obstructions?	N/A	N/A	Storm Grate/Utility Type	N/A
			N/A	Obstruction Type	N/A	N/A	Surface Condition? (G/P)	Good
