Intersection ID: 10022367		Main Street: CAMFIELD_ST		Cross Street: N/A		Location:		NW											
ADA ID: 6806F668961E		Ramp Type: PerpDiag		Initial Pass/Fail: Fail		Overall Compliance: No		Severity Score: 21.25											
Codes/Mitigation Info/Possible Solution				Field Measurements/Component Compliance

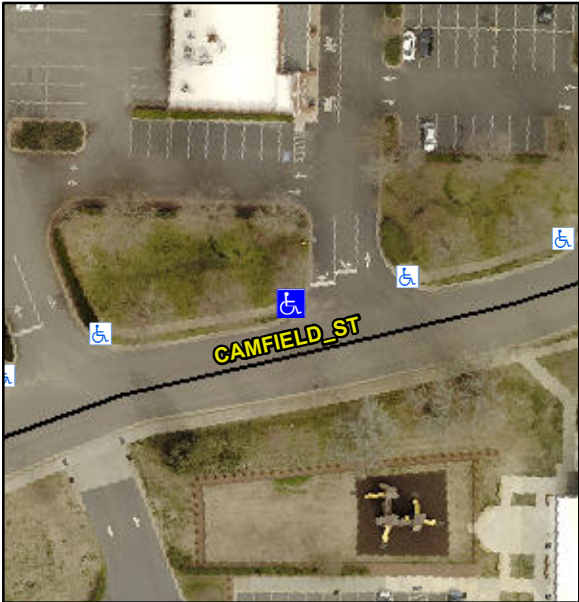
N/A		Landing Length (in)		N/A		N/A		DWS Provided?		N/A			
						N/A		Landing Width (in)		N/A		N/A		DWS Contrast?		N/A			
						N/A		Landing Slope (%)		N/A		N/A		DWS Length (in)		N/A			
						N/A		Landing X Slope (%)		N/A		N/A		DWS Full Width?		N/A			
<div>Surveyor Notes:</div> <div>N/A</div> <div>PROW/ADA:</div> <div>Not Found, R304.5.1, R304.2.2</div>						N/A		Landing Curb? (Y/N)		N/A		N/A		DWS Offset (in)		N/A			
						N/A		Shared Landing?		N/A									
						N/A		Gutter Ponding?		N/A		N/A		Gutter Slope (%)		N/A			
						N/A		Gutter Lip Ht (in)		N/A		N/A		Gutter X Slope (%)		N/A			
						N/A		Painted X Walk1?		No		N/A		Painted X Walk2?		No			
								X Walk 1 Direction		To S				X Walk 2 Direction		To E			
						N/A		X Walk 1 Width (in)		N/A		N/A		X Walk 2 Width (in)		N/A			
								X Walk 1 Slope (%)		0.9				X Walk 2 Slope (%)		0.7			
								X Walk 1 X Slope (%)		1.7				X Walk 2 X Slope (%)		0.2

<div>Street 1 NameCAMFIELD ST</div> <div>Stop Condition-Street 2None</div> <div>Street 2 NameENTRANCE</div> <div>Stop Condition-Street 1StopSign</div>				Possible Solutions:		Compliance		Description		Data		Compliance		Description		Data			
				Remove & Replace Curb Ramp With Two New Directional Ramps or Equivalent.		N/A		Ramp Length (in)		97.0		No		Ramp Slope (%)		8.6			
						No		Ramp Width (in)		44.5		Yes		Ramp XSlope (%)		0.6			
						N/A		Flare Type LT		N/A		N/A		Flare Type RT		N/A			
						N/A		Flare Slope LT (%)		N/A		N/A		Flare Slope RT (%)		N/A			
						N/A		Flare Traversable LT?		N/A		N/A		Flare Traversable RT?		N/A
