Access Compliance Report

Public Rights-of-Way

(Curb Ramps)

Intersection ID: 31220	Main Street: OAKTON_HUNT_DR	Cross Street: CAPRINGTON_AV	Location: E
ADA ID: 680FC6DACB2D	Ramp Type: PerpDiag	Initial Pass/Fail: Fail	Overall Compliance: No
Severity Score: 8.75			
Codes/Mitigation Info/Possible Solution		Field Measurements/Component Compliance

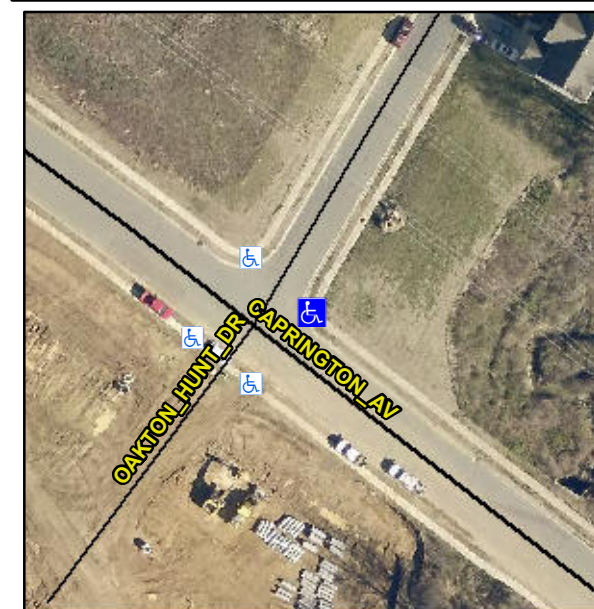
Not Found, R304.5.1

Compliance	Description	Data	Compliance	Description	Data
N/A	Ramp Length (in)	48.0	Yes	Ramp Slope (%)	5.0
No	Ramp Width (in)	46.0	Yes	Ramp XSlope (%)	0.5
N/A	Flare Type LT	N/A	N/A	Flare Type RT	N/A
N/A	Flare Slope LT (%)	N/A	N/A	Flare Slope RT (%)	N/A
N/A	Flare Traversable LT?	N/A	N/A	Flare Traversable RT?	N/A
N/A	Landing Length (in)	N/A	N/A	DWS Provided?	N/A
N/A	Landing Width (in)	N/A	N/A	DWS Contrast?	N/A
N/A	Landing Slope (%)	N/A	N/A	DWS Length (in)	N/A
N/A	Landing X Slope (%)	N/A	N/A	DWS Full Width?	N/A
N/A	Landing Curb? (Y/N)	N/A	N/A	DWS Offset (in)	N/A
N/A	Shared Landing?	N/A			
N/A	Gutter Ponding?	N/A	N/A	Gutter Slope (%)	N/A
N/A	Gutter Lip Ht (in)	N/A	N/A	Gutter X Slope (%)	N/A
N/A	Painted X Walk1?	No	N/A	Painted X Walk2?	No
	X Walk 1 Direction	To NW		X Walk 2 Direction	To SW
N/A	X Walk 1 Width (in)	N/A	N/A	X Walk 2 Width (in)	N/A
	X Walk 1 Slope (%)	2.2		X Walk 2 Slope (%)	2.3
	X Walk 1 X Slope (%)	1.9		X Walk 2 X Slope (%)	1.5

N/A	Ramp inside XWalk1?	N/A	N/A	Ramp inside XWalk2?	N/A
	Road Slope (%)	1.9	N/A	Clear Space?	N/A
	Road X Slope (%)	2.7	N/A	Clear Space to XWalk (in)	N/A
N/A	Any Obstructions?	N/A	N/A	Storm Grate/Utility Hazard?	N/A
	Obstruction Type			Storm Grate/Utility Type	
		N/A			N/A
		Yes		Surface Condition? (G/P)	Good

Remove & Replace Curb Ramp With Two New Directional Ramps or Equivalent.

Total Cost: \$ 3200.00
