## Access Compliance Report Public Rights-of-Way (Curb Ramps)

Intersection ID: 14306	14306 Main Street: HARRISBURG_RD			Street:	PARKTON_RD	Location:	NE		
ADA ID: 68254F7903AD	8254F7903AD Ramp Type: PerpDiag			Initial Pass/Fail: Fail Overall Compliance: No				o Severity Score:	33.75
Codes/Mitigation Info/Possible Solution				Field Measurements/Component Compliance					
	A RADATE AL	Possible Solutions:		Compliance Description			ata Compliance Description		Data
		Remove & Replace Curb Ramp	With	N/A	Ramp Length (in)	60.0	No	Ramp Slope (%)	10.2
		Two New Directional Ramps or		No	Ramp Width (in)	39.0	No	Ramp XSlope (%)	6.7
		Equivalent.		N/A	Flare Type LT	N/A	N/A	Flare Type RT	N/A
The second second				N/A	Flare Slope LT (%)	N/A	N/A	Flare Slope RT (%)	N/A
				N/A	Flare Traversable LT?	N/A	N/A	Flare Traversable RT?	N/A
E		2		N/A	Landing Length (in)	N/A	N/A	DWS Provided?	N/A
		Surveyor Notes:		N/A	Landing Width (in)	N/A	N/A	DWS Contrast?	N/A
		N/A		N/A	Landing Slope (%)	N/A	N/A	DWS Length (in)	N/A

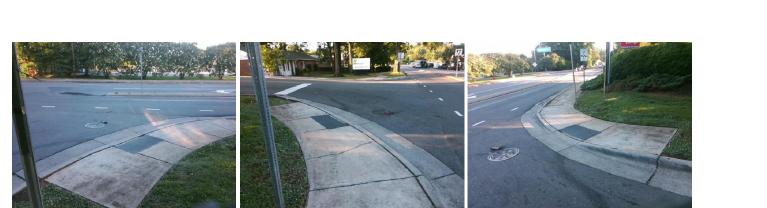
1/2		N/A	Landing X Slope (%)	N/A	N/A	DWS Full Width?	N/A
				N/A	Landing Curb? (Y/N)	N/A	N/A	DWS Offset (in)	N/A
				N/A	Shared Landing?	N/A			
	and the second	PROW/ADA:		N/A	Gutter Ponding?	N/A	N/A	Gutter Slope (%)	N/A
Not Found, R304.5.1, R304.2.2, R304.5.3				N/A	Gutter Lip Ht (in)	N/A	N/A	Gutter X Slope (%)	N/A
				N/A	Painted X Walk1?	No	N/A	Painted X Walk2?	N/A No
				N/A	X Walk 1 Direction	To W	N/A	X Walk 2 Direction	To S
				NI/A					
			N/A	X Walk 1 Width (in)	N/A	N/A	X Walk 2 Width (in)	N/A	
Street 1 Name	HARRISBURG RD				X Walk 1 Slope (%)	3.1		X Walk 2 Slope (%)	5.3
Stop Condition-Street 2	None				X Walk 1 X Slope (%)	1.7		X Walk 2 X Slope (%)	3.9
Street 2 Name	PARKTON RD			N/A	Ramp inside XWalk1?	N/A	N/A	Ramp inside XWalk2?	N/A
Stop Condition-Street 1	StopSign				Road Slope (%)	4.3	N/A	Clear Space?	N/A
					Road X Slope (%)	1.2	N/A	Clear Space to XWalk (in)	N/A
				N/A	Any Obstructions?	N/A	N/A	Storm Grate/Utility Hazard?	N/A

Yes Surface Condition? (G/P)

Good

Total Cost: \$	3200.00		Obstruction Type			Storm Grate/Utility Type	
						N/A			N/A
