# Access Compliance Report

## Public Rights-of-Way

Intersection ID: 13809	Main Street: CHESTERFIELD_AV	Cross Street: ST_JULIEN_ST	Location:	N
ADA ID: 682D84F433C2	Ramp Type: PerpDiag	Initial Pass/Fail: Fail	Overall Compliance: No	Severity Score: 12.5
Codes/Mitigation Info/Possible Solution		Field Measurements/Component Compliance

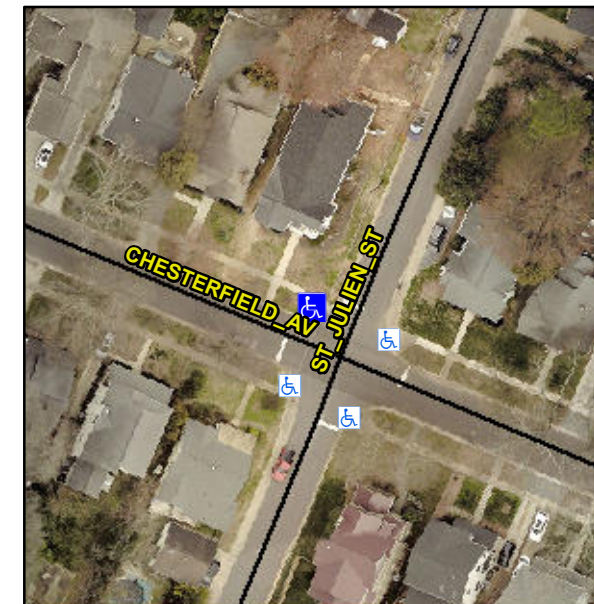
Compliance	Description	Data	Compliance	Description	Data
N/A	Ramp Length (in)	63.0	No	Ramp Slope (%)	8.6
Yes	Ramp Width (in)	50.0	Yes	Ramp XSlope (%)	1.1
N/A	Flare Type LT	N/A	N/A	Flare Type RT	N/A
N/A	Flare Slope LT (%)	N/A	N/A	Flare Slope RT (%)	N/A
N/A	Flare Traversable LT?	N/A	N/A	Flare Traversable RT?	N/A
N/A	Landing Length (in)	N/A	N/A	DWS Provided?	N/A
N/A	Landing Width (in)	N/A	N/A	DWS Contrast?	N/A
N/A	Landing Slope (%)	N/A	N/A	DWS Length (in)	N/A
N/A	Landing X Slope (%)	N/A	N/A	DWS Full Width?	N/A
N/A	Landing Curb? (Y/N)	N/A	N/A	DWS Offset (in)	N/A
N/A	Shared Landing?	N/A			
N/A	Gutter Ponding?	N/A	N/A	Gutter Slope (%)	N/A
N/A	Gutter Lip Ht (in)	0.5	N/A	Gutter X Slope (%)	N/A
N/A	Painted X Walk1?	No	N/A	Painted X Walk2?	No
	X Walk 1 Direction	To SW		X Walk 2 Direction	To SE
N/A	X Walk 1 Width (in)	N/A	N/A	X Walk 2 Width (in)	N/A
	X Walk 1 Slope (%)	5.5		X Walk 2 Slope (%)	0.9
	X Walk 1 X Slope (%)	1.9		X Walk 2 X Slope (%)	0.1

N/A	Ramp inside XWalk1?	N/A	N/A	Ramp inside XWalk2?	N/A
	Road Slope (%)	3.0	N/A	Clear Space?	N/A
	Road X Slope (%)	2.3	N/A	Clear Space to XWalk (in)	N/A
N/A	Any Obstructions?	N/A	N/A	Storm Grate/Utility Hazard?	N/A
	Obstruction Type			Storm Grate/Utility Type	
		N/A			N/A
			Yes	Surface Condition? (G/P)	Good

**Remove & Replace Curb Ramp With Two New Directional Ramps or Equivalent.**
