Intersection ID: 27272	Main Street: ELMSTONE_DR	Cross Street: STONEPATH_LN	Location:	SE
ADA ID: 6838844F7674	Ramp Type: PerpDiag	Initial Pass/Fail: Fail	Overall Compliance: No	Severity Score: 37.5

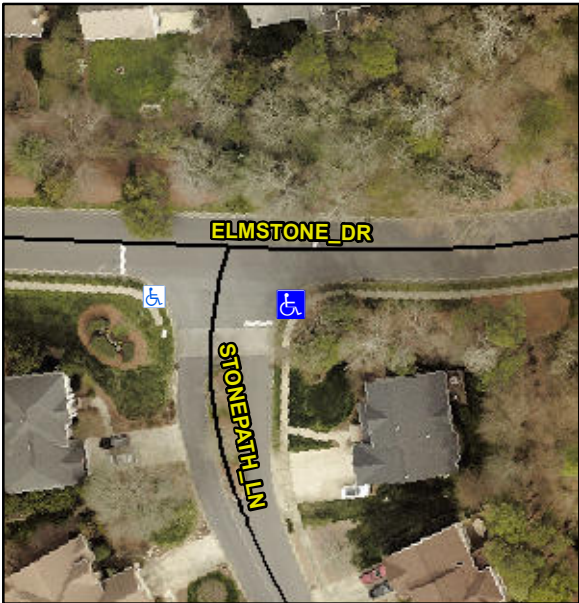
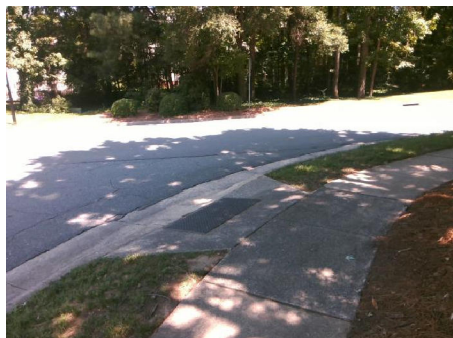
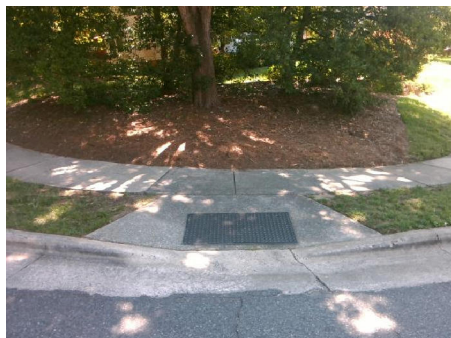
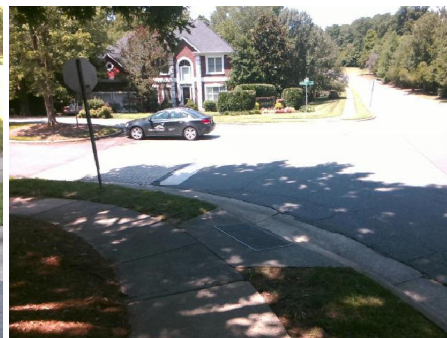
Possible Solutions:		Compliance	Description	Data	Compliance	Description	Data
	Remove & Replace Curb Ramp With Two New Directional Ramps or Equivalent.		N/A	Ramp Length (in)	49.0	No	Ramp Slope (%)	14.5
			Yes	Ramp Width (in)	48.0	No	Ramp XSlope (%)	6.2
			N/A	Flare Type LT	N/A	N/A	Flare Type RT	N/A
	Surveyor Notes:  N/A		N/A	Flare Slope LT (%)	N/A	N/A	Flare Slope RT (%)	N/A
			N/A	Flare Traversable LT?	N/A	N/A	Flare Traversable RT?	N/A
			N/A	Landing Length (in)	N/A	N/A	DWS Provided?	N/A
			N/A	Landing Width (in)	N/A	N/A	DWS Contrast?	N/A
			N/A	Landing Slope (%)	N/A	N/A	DWS Length (in)	N/A
			N/A	Landing X Slope (%)	N/A	N/A	DWS Full Width?	N/A
N/A			Landing Curb? (Y/N)	N/A	N/A	DWS Offset (in)	N/A	
PROW/ADA:		N/A	Shared Landing?	N/A				
Not Found, R304.2.2, R304.5.3		N/A	Gutter Ponding?	N/A	N/A	Gutter Slope (%)	N/A

N/A	Gutter Lip Ht (in)	N/A	N/A	Gutter X Slope (%)	N/A	
		N/A	Painted X Walk1?	No	N/A	Painted X Walk2?	No	
			X Walk 1 Direction	To N		X Walk 2 Direction	To W	
		N/A	X Walk 1 Width (in)	N/A	N/A	X Walk 2 Width (in)	N/A	
			X Walk 1 Slope (%)	2.9		X Walk 2 Slope (%)	3.5	
			X Walk 1 X Slope (%)	4.0		X Walk 2 X Slope (%)	5.4	
		N/A	Ramp inside XWalk1?	N/A	N/A	Ramp inside XWalk2?	N/A	
			Road Slope (%)	5.4	N/A	Clear Space?	N/A	
			Road X Slope (%)	0.8	N/A	Clear Space to XWalk (in)	N/A	
		N/A	Any Obstructions?	N/A	N/A	Storm Grate/Utility Hazard?	N/A	
			Obstruction Type			Storm Grate/Utility Type		
					N/A		N/A	
						Yes	Surface Condition? (G/P)	Good
Street 1 Name		ELMSTONE DR						
Stop Condition-Street 2		StopSign						
Street 2 Name		STONEPATH LN						
Stop Condition-Street 1		StopSign						
Total Cost:		\$ 3200.00
