# Access Compliance Report

## Public Rights-of-Way

### (Curb Ramps)

Intersection ID: 13911	Main Street: LEXINGTON_AV	Cross Street: ORIOLE_AV	Location: E
ADA ID: 683AC9E30930	Ramp Type: Perp	Initial Pass/Fail: Fail	Overall Compliance: No
Severity Score: 13.75			
Codes/Mitigation Info/Possible Solution		Field Measurements/Component Compliance

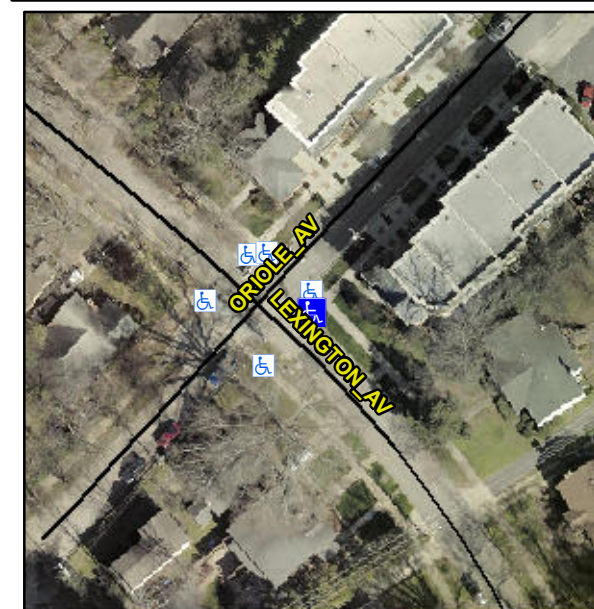
**Not Found, R304.2.2, R304.5.3**

Compliance	Description	Data	Compliance	Description	Data
N/A	Ramp Length (in)	82.0	No	Ramp Slope (%)	9.0
Yes	Ramp Width (in)	48.0	No	Ramp XSlope (%)	2.9
N/A	Flare Type LT	N/A	N/A	Flare Type RT	N/A
N/A	Flare Slope LT (%)	N/A	N/A	Flare Slope RT (%)	N/A
N/A	Flare Traversable LT?	N/A	N/A	Flare Traversable RT?	N/A
N/A	Landing Length (in)	N/A	N/A	DWS Provided?	N/A
N/A	Landing Width (in)	N/A	N/A	DWS Contrast?	N/A
N/A	Landing Slope (%)	N/A	N/A	DWS Length (in)	N/A
N/A	Landing X Slope (%)	N/A	N/A	DWS Full Width?	N/A
N/A	Landing Curb? (Y/N)	N/A	N/A	DWS Offset (in)	N/A
N/A	Shared Landing?	N/A			
N/A	Gutter Ponding?	N/A	N/A	Gutter Slope (%)	N/A
N/A	Gutter Lip Ht (in)	N/A	N/A	Gutter X Slope (%)	N/A
N/A	Painted X Walk1?	No	N/A	Painted X Walk2?	N/A
	X Walk 1 Direction	To SW		X Walk 2 Direction	N/A
N/A	X Walk 1 Width (in)	N/A	N/A	X Walk 2 Width (in)	N/A
	X Walk 1 Slope (%)	3.7		X Walk 2 Slope (%)	N/A
	X Walk 1 X Slope (%)	1.6		X Walk 2 X Slope (%)	N/A

N/A	Ramp inside XWalk1?	N/A	N/A	Ramp inside XWalk2?	N/A
	Road Slope (%)	N/A	N/A	Clear Space?	N/A
	Road X Slope (%)	N/A	N/A	Clear Space to XWalk (in)	N/A
N/A	Any Obstructions?	N/A	N/A	Storm Grate/Utility Hazard?	N/A
	Obstruction Type			Storm Grate/Utility Type	
		N/A			N/A
		Yes		Surface Condition? (G/P)	Good

**Remove & Replace Entire Ramp.**
