Intersection ID: 13086	Main Street: CENTRAL_AV	Cross Street: CLEMENT_AV	Location:	NE
ADA ID: 68446A4D93CC	Ramp Type: Perp	Initial Pass/Fail: Fail	Overall Compliance: No	Severity Score: 13.75

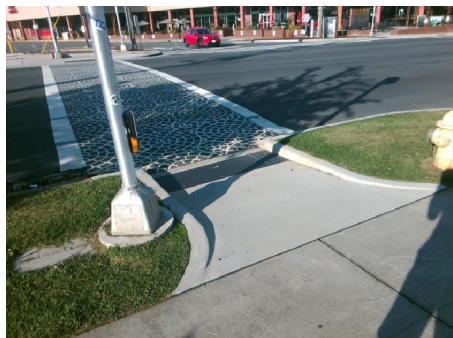
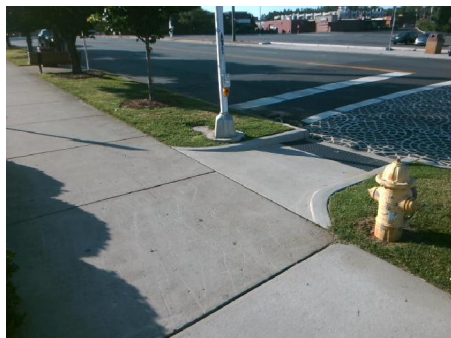
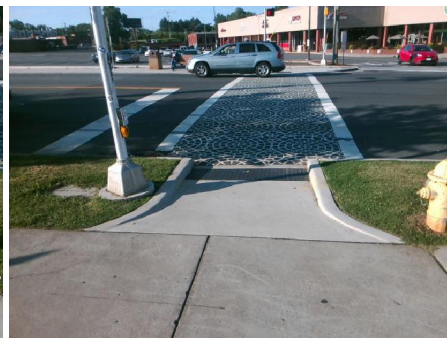
Compliance	Description	Data	Compliance	Description	Data
N/A	Ramp Length (in)	95.0	No	Ramp Slope (%)	9.4
Yes	Ramp Width (in)	69.0	No	Ramp XSlope (%)	2.4
N/A	Flare Type LT	N/A	N/A	Flare Type RT	N/A
N/A	Flare Slope LT (%)	N/A	N/A	Flare Slope RT (%)	N/A
N/A	Flare Traversable LT?	N/A	N/A	Flare Traversable RT?	N/A
N/A	Landing Length (in)	N/A	N/A	DWS Provided?	N/A
N/A	Landing Width (in)	N/A	N/A	DWS Contrast?	N/A
N/A	Landing Slope (%)	N/A	N/A	DWS Length (in)	N/A
N/A	Landing X Slope (%)	N/A	N/A	DWS Full Width?	N/A
N/A	Landing Curb? (Y/N)	N/A	N/A	DWS Offset (in)	N/A
N/A	Shared Landing?	N/A			
N/A	Gutter Ponding?	N/A	N/A	Gutter Slope (%)	N/A
N/A	Gutter Lip Ht (in)	N/A	N/A	Gutter X Slope (%)	N/A
N/A	Painted X Walk1?	Yes	N/A	Painted X Walk2?	N/A
	X Walk 1 Direction	To S		X Walk 2 Direction	N/A
N/A	X Walk 1 Width (in)	122.0	N/A	X Walk 2 Width (in)	N/A
	X Walk 1 Slope (%)	4.5		X Walk 2 Slope (%)	N/A
	X Walk 1 X Slope (%)	1.7		X Walk 2 X Slope (%)	N/A

N/A	Ramp inside XWalk1?	Yes	N/A	Ramp inside XWalk2?	N/A
	Road Slope (%)	N/A	N/A	Clear Space?	N/A
	Road X Slope (%)	N/A	N/A	Clear Space to XWalk (in)	N/A
N/A	Any Obstructions?	N/A	N/A	Storm Grate/Utility Hazard?	N/A
	Obstruction Type			Storm Grate/Utility Type	
		N/A			N/A
			Yes	Surface Condition? (G/P)	Good

Remove & Replace Entire Ramp.
