# Access Compliance Report

## Public Rights-of-Way

### (Curb Ramps)

Intersection ID: 13398	Main Street: CENTRAL_AV	Cross Street: ST_GEORGE_ST	Location: SE
ADA ID: 684663394DA5	Ramp Type: Perp	Initial Pass/Fail: Fail	Overall Compliance: No
Severity Score: 10			
Codes/Mitigation Info/Possible Solution		Field Measurements/Component Compliance

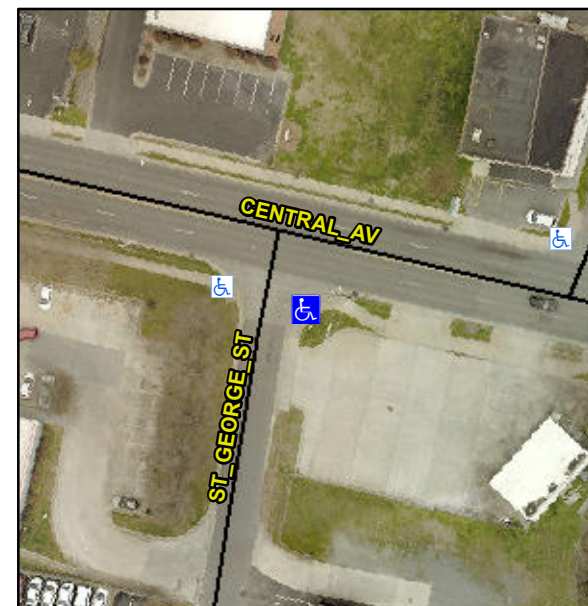
**Not Found, R304.5.1, R304.5.3**

Compliance	Description	Data	Compliance	Description	Data
N/A	Ramp Length (in)	47.0	Yes	Ramp Slope (%)	5.1
No	Ramp Width (in)	44.0	No	Ramp XSlope (%)	2.8
N/A	Flare Type LT	N/A	N/A	Flare Type RT	N/A
N/A	Flare Slope LT (%)	N/A	N/A	Flare Slope RT (%)	N/A
N/A	Flare Traversable LT?	N/A	N/A	Flare Traversable RT?	N/A
N/A	Landing Length (in)	N/A	N/A	DWS Provided?	N/A
N/A	Landing Width (in)	N/A	N/A	DWS Contrast?	N/A
N/A	Landing Slope (%)	N/A	N/A	DWS Length (in)	N/A
N/A	Landing X Slope (%)	N/A	N/A	DWS Full Width?	N/A
N/A	Landing Curb? (Y/N)	N/A	N/A	DWS Offset (in)	N/A
N/A	Shared Landing?	N/A			
N/A	Gutter Ponding?	N/A	N/A	Gutter Slope (%)	N/A
N/A	Gutter Lip Ht (in)	N/A	N/A	Gutter X Slope (%)	N/A
N/A	Painted X Walk1?	No	N/A	Painted X Walk2?	N/A
	X Walk 1 Direction	To NW		X Walk 2 Direction	N/A
N/A	X Walk 1 Width (in)	N/A	N/A	X Walk 2 Width (in)	N/A
	X Walk 1 Slope (%)	3.9		X Walk 2 Slope (%)	N/A
	X Walk 1 X Slope (%)	4.0		X Walk 2 X Slope (%)	N/A

N/A	Ramp inside XWalk1?	N/A	N/A	Ramp inside XWalk2?	N/A
	Road Slope (%)	N/A	N/A	Clear Space?	N/A
	Road X Slope (%)	N/A	N/A	Clear Space to XWalk (in)	N/A
N/A	Any Obstructions?	N/A	N/A	Storm Grate/Utility Hazard?	N/A
	Obstruction Type			Storm Grate/Utility Type	
		N/A			N/A
			Yes	Surface Condition? (G/P)	Good

**Remove & Replace Entire Ramp.**
