# Access Compliance Report

## Public Rights-of-Way

### (Curb Ramps)

Intersection ID: 43353	Main Street: PROSPERITY RIDGE RD	Cross Street: PROSPERITY COMMONS DR	Location: W
ADA ID: 684781FBC8E2	Ramp Type: PerpDiag	Initial Pass/Fail: Fail	Overall Compliance: No
Codes/Mitigation Info/Possible Solution			Severity Score: 10
			Field Measurements/Component Compliance

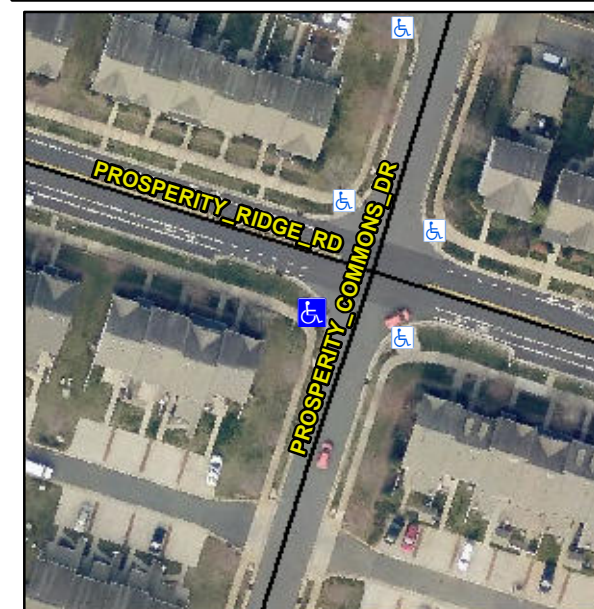
**Not Found, R304.5.1, R304.5.3**

Compliance	Description	Data	Compliance	Description	Data
N/A	Ramp Length (in)	87.0	Yes	Ramp Slope (%)	5.6
No	Ramp Width (in)	42.0	No	Ramp XSlope (%)	2.5
N/A	Flare Type LT	N/A	N/A	Flare Type RT	N/A
N/A	Flare Slope LT (%)	N/A	N/A	Flare Slope RT (%)	N/A
N/A	Flare Traversable LT?	N/A	N/A	Flare Traversable RT?	N/A
N/A	Landing Length (in)	N/A	N/A	DWS Provided?	N/A
N/A	Landing Width (in)	N/A	N/A	DWS Contrast?	N/A
N/A	Landing Slope (%)	N/A	N/A	DWS Length (in)	N/A
N/A	Landing X Slope (%)	N/A	N/A	DWS Full Width?	N/A
N/A	Landing Curb? (Y/N)	N/A	N/A	DWS Offset (in)	N/A
N/A	Shared Landing?	N/A			
N/A	Gutter Ponding?	N/A	N/A	Gutter Slope (%)	N/A
N/A	Gutter Lip Ht (in)	N/A	N/A	Gutter X Slope (%)	N/A
N/A	Painted X Walk1?	No	N/A	Painted X Walk2?	No
	X Walk 1 Direction	To SE		X Walk 2 Direction	To NE
N/A	X Walk 1 Width (in)	N/A	N/A	X Walk 2 Width (in)	N/A
	X Walk 1 Slope (%)	1.2		X Walk 2 Slope (%)	3.6
	X Walk 1 X Slope (%)	4.8		X Walk 2 X Slope (%)	0.1

N/A	Ramp inside XWalk1?	N/A	N/A	Ramp inside XWalk2?	N/A
	Road Slope (%)	2.5	N/A	Clear Space?	N/A
	Road X Slope (%)	4.1	N/A	Clear Space to XWalk (in)	N/A
N/A	Any Obstructions?	N/A	N/A	Storm Grate/Utility Hazard?	N/A
	Obstruction Type			Storm Grate/Utility Type	
		N/A			N/A
			Yes	Surface Condition? (G/P)	Good

**Remove & Replace Curb Ramp With Two New Directional Ramps or Equivalent.**

Total Cost: \$ 3200.00
