Access Compliance Report

Public Rights-of-Way

(Curb Ramps)

Intersection ID: 24585	Main Street: REA_CROFT_DR	Cross Street: REA_RD	Location: SW
ADA ID: 6865DF684D83	Ramp Type: Perp	Initial Pass/Fail: Fail	Overall Compliance: No Severity Score: 13.75

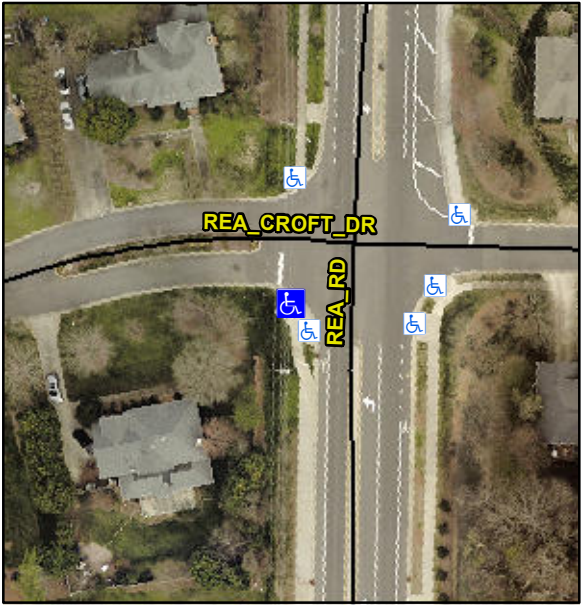
Possible Solutions:		Compliance	Description	Data
	Remove & Replace Entire Ramp.		No	Ramp Length (in)	65.0
			Yes	Ramp Width (in)	48.0
			N/A	Flare Type LT	N/A
			N/A	Flare Slope LT (%)	N/A
			N/A	Flare Traversable LT?	N/A
			N/A	Landing Length (in)	N/A
			N/A	Landing Width (in)	N/A
			N/A	Landing Slope (%)	N/A
			N/A	Landing X Slope (%)	N/A
<p>Surveyor Notes:</p> <p>N/A</p> <p>PROW/ADA:</p> <p>Not Found, R304.2.2, R304.5.3</p>			N/A	Flare Type RT	N/A
			N/A	Flare Slope RT (%)	N/A
			N/A	Flare Traversable RT?	N/A
			N/A	DWS Provided?	N/A
			N/A	DWS Contrast?	N/A
			N/A	DWS Length (in)	N/A
			N/A	DWS Full Width?	N/A
			N/A	DWS Offset (in)	N/A
			N/A	Gutter Ponding?	N/A
			N/A	Gutter Lip Ht (in)	N/A
			No	Painted X Walk1?	N/A
				X Walk 1 Direction	To N
			N/A	X Walk 1 Width (in)	N/A
				X Walk 1 Slope (%)	3.6
				X Walk 1 X Slope (%)	1.8

N/A	Ramp inside XWalk1?	N/A
			N/A	Road Slope (%)	N/A
			N/A	Road X Slope (%)	N/A
			N/A	Any Obstructions?	N/A
				Obstruction Type	
Total Cost:		\$ 1850.00	N/A	Storm Grate/Utility Hazard?	N/A
			N/A	Storm Grate/Utility Type	N/A
			Yes	Surface Condition? (G/P)	Good
