Access Compliance Report

Public Rights-of-Way

(Curb Ramps)

Intersection ID: 21209	Main Street: GALLERIA_BV	Cross Street: SARDIS_RD_NORTH	Location: NE
ADA ID: 68686EC19818	Ramp Type: Perp	Initial Pass/Fail: Fail	Overall Compliance: No
Severity Score: 10			
Codes/Mitigation Info/Possible Solution		Field Measurements/Component Compliance

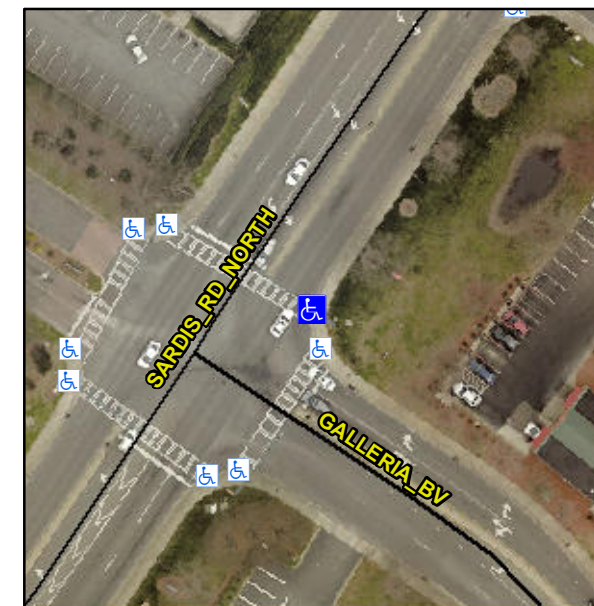
Compliance	Description	Data	Compliance	Description	Data
N/A	Ramp Length (in)	36.3	Yes	Ramp Slope (%)	7.9
No	Ramp Width (in)	43.5	Yes	Ramp XSlope (%)	2.6
N/A	Flare Type LT	N/A	N/A	Flare Type RT	N/A
N/A	Flare Slope LT (%)	N/A	N/A	Flare Slope RT (%)	N/A
N/A	Flare Traversable LT?	N/A	N/A	Flare Traversable RT?	N/A
N/A	Landing Length (in)	N/A	N/A	DWS Provided?	N/A
N/A	Landing Width (in)	N/A	N/A	DWS Contrast?	N/A
N/A	Landing Slope (%)	N/A	N/A	DWS Length (in)	N/A
N/A	Landing X Slope (%)	N/A	N/A	DWS Full Width?	N/A
N/A	Landing Curb? (Y/N)	N/A	N/A	DWS Offset (in)	N/A
N/A	Shared Landing?	N/A			
N/A	Gutter Ponding?	N/A	N/A	Gutter Slope (%)	N/A
N/A	Gutter Lip Ht (in)	N/A	N/A	Gutter X Slope (%)	N/A
N/A	Painted X Walk1?	Yes	N/A	Painted X Walk2?	N/A
	X Walk 1 Direction	To NW		X Walk 2 Direction	N/A
N/A	X Walk 1 Width (in)	88.0	N/A	X Walk 2 Width (in)	N/A
	X Walk 1 Slope (%)	1.4		X Walk 2 Slope (%)	N/A
	X Walk 1 X Slope (%)	3.0		X Walk 2 X Slope (%)	N/A

N/A	Ramp inside XWalk1?	Yes	N/A	Ramp inside XWalk2?	N/A
	Road Slope (%)	N/A	N/A	Clear Space?	N/A
	Road X Slope (%)	N/A	N/A	Clear Space to XWalk (in)	N/A
N/A	Any Obstructions?	N/A	N/A	Storm Grate/Utility Hazard?	N/A
	Obstruction Type			Storm Grate/Utility Type	
		N/A			N/A
		Yes		Surface Condition? (G/P)	Good

Possible Solutions:

Remove & Replace Entire Ramp.

R304.5.1
