Access Compliance Report

Public Rights-of-Way

(Curb Ramps)

Intersection ID: 12629	Main Street: E_6TH_ST	Cross Street: N_DAVIDSON_ST	Location: NE
ADA ID: 686C5DE7D602	Ramp Type: Perp	Initial Pass/Fail: Fail	Overall Compliance: No
Severity Score: 22.5			
Codes/Mitigation Info/Possible Solution		Field Measurements/Component Compliance

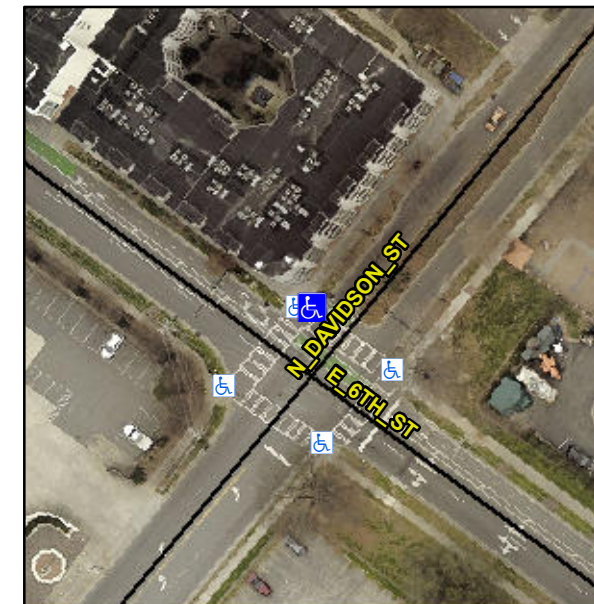
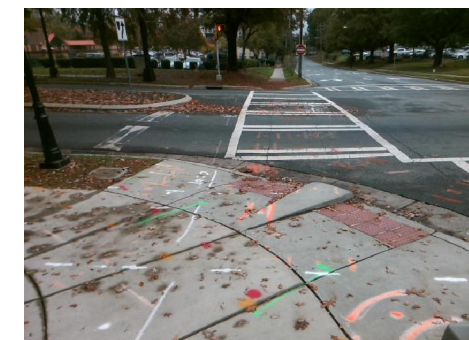
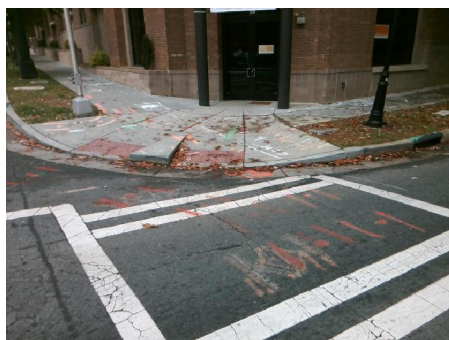
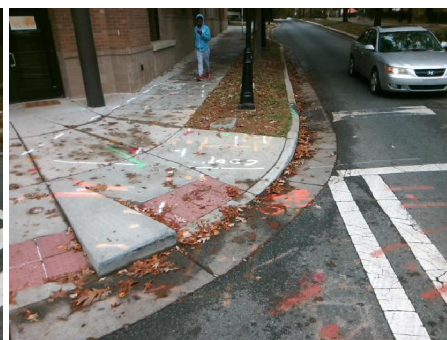
Not Found, R304.5.1, R304.2.2

Compliance	Description	Data	Compliance	Description	Data
N/A	Ramp Length (in)	68.5	No	Ramp Slope (%)	8.8
No	Ramp Width (in)	46.0	Yes	Ramp XSlope (%)	2.4
N/A	Flare Type LT	N/A	N/A	Flare Type RT	N/A
N/A	Flare Slope LT (%)	N/A	N/A	Flare Slope RT (%)	N/A
N/A	Flare Traversable LT?	N/A	N/A	Flare Traversable RT?	N/A
N/A	Landing Length (in)	N/A	N/A	DWS Provided?	N/A
N/A	Landing Width (in)	N/A	N/A	DWS Contrast?	N/A
N/A	Landing Slope (%)	N/A	N/A	DWS Length (in)	N/A
N/A	Landing X Slope (%)	N/A	N/A	DWS Full Width?	N/A
N/A	Landing Curb? (Y/N)	N/A	N/A	DWS Offset (in)	N/A
N/A	Shared Landing?	N/A			
N/A	Gutter Ponding?	N/A	N/A	Gutter Slope (%)	N/A
N/A	Gutter Lip Ht (in)	0.5	N/A	Gutter X Slope (%)	N/A
N/A	Painted X Walk1?	Yes	N/A	Painted X Walk2?	N/A
	X Walk 1 Direction	To SE		X Walk 2 Direction	N/A
N/A	X Walk 1 Width (in)	112.0	N/A	X Walk 2 Width (in)	N/A
	X Walk 1 Slope (%)	3.6		X Walk 2 Slope (%)	N/A
	X Walk 1 X Slope (%)	3.6		X Walk 2 X Slope (%)	N/A

N/A	Ramp inside XWalk1?	Yes	N/A	Ramp inside XWalk2?	N/A
	Road Slope (%)	N/A	N/A	Clear Space?	N/A
	Road X Slope (%)	N/A	N/A	Clear Space to XWalk (in)	N/A
N/A	Any Obstructions?	N/A	N/A	Storm Grate/Utility Hazard?	N/A
	Obstruction Type			Storm Grate/Utility Type	
		N/A			N/A
			Yes	Surface Condition? (G/P)	Good

Possible Solutions:

Remove & Replace Entire Ramp.
