Access Compliance Report Public Rights-of-Way (Curb Ramps)

Intersection ID: 44171 Main Street: BELLEGARDE DR Cross Street: REA_RD Location: NE **Overall Compliance: No** Ramp Type: Perp ADA ID: 687FA74DD2BA Initial Pass/Fail: Fail **Severity Score:** 8.75

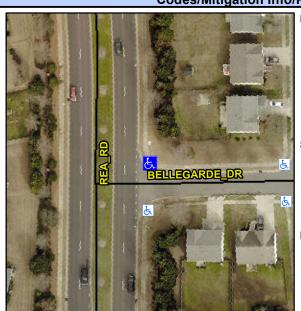
Comp	liance Description	Data	Compl	iance	Description	Data
N/A	Ramp Length (in)	43.5	Yes	Ramp	Slope (%)	8.3
No	Ramp Width (in)	42.0	Yes	Ramp	XSlope (%)	0.1
N/A	Flare Type LT	N/A	N/A	Flare	Type RT	N/A
N/A	Flare Slope LT (%)	N/A	N/A	Flare	Slope RT (%)	N/A
N/A	Flare Traversable LT?	N/A	N/A	Flare	Traversable RT?	N/A
N/A	Landing Length (in)	N/A	N/A	DWS	Provided?	N/A
N/A	Landing Width (in)	N/A	N/A	DWS	Contrast?	N/A
N/A	Landing Slope (%)	N/A	N/A	DWS	Length (in)	N/A
N/A	Landing X Slope (%)	N/A	N/A	DWS	Full Width?	N/A
N/A	Landing Curb? (Y/N)	N/A	N/A	DWS	Offset (in)	N/A
N/A	Shared Landing?	N/A				
N/A	Gutter Ponding?	N/A	N/A	Gutte	r Slope (%)	N/A
N/A	Gutter Lip Ht (in)	N/A	N/A	Gutte	r X Slope (%)	N/A
N/A	Painted X Walk1?	No	N/A	Paint	ed X Walk2?	N/A
	X Walk 1 Direction	To S		X Wa	lk 2 Direction	N/A
N/A	X Walk 1 Width (in)	N/A	N/A	X Wa	lk 2 Width (in)	N/A
	X Walk 1 Slope (%)	2.1		X Wa	lk 2 Slope (%)	N/A
	X Walk 1 X Slope (%)	0.9		X Wa	lk 2 X Slope (%)	N/A

OSSIBIC COIGUION							
Possible Solutions:							
Remove & Replace Entire Ramp.							
o							
Surveyor Notes:							
N/A							
PROW/ADA:							
R304.5.1
