Access Compliance Report

Public Rights-of-Way

(Curb Ramps)

Intersection ID: 27595	Main Street: BALLANTYNE COMMONS PY	Cross Street: BALLANTYNE MEADOWS DR	Location: SE
ADA ID: 689C22935966	Ramp Type: Perp	Initial Pass/Fail: Fail	Overall Compliance: No
Severity Score: 12.5			
Codes/Mitigation Info/Possible Solution		Field Measurements/Component Compliance

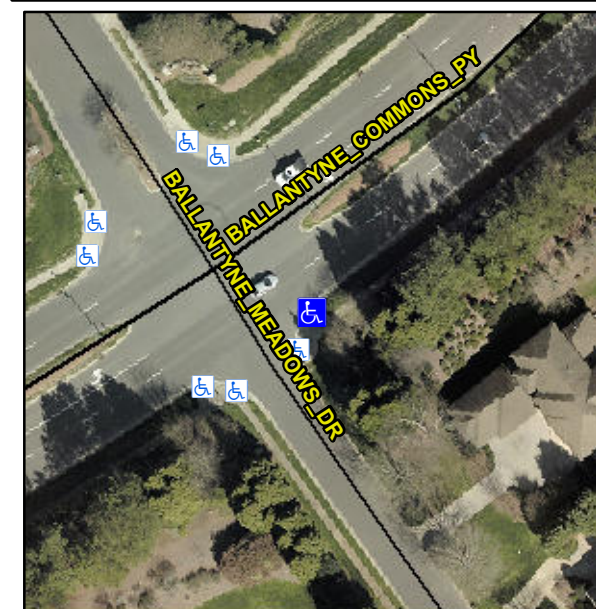
Not Found, R304.5.3

Compliance	Description	Data	Compliance	Description	Data
N/A	Ramp Length (in)	79.0	Yes	Ramp Slope (%)	6.3
Yes	Ramp Width (in)	49.0	No	Ramp XSlope (%)	5.5
N/A	Flare Type LT	N/A	N/A	Flare Type RT	N/A
N/A	Flare Slope LT (%)	N/A	N/A	Flare Slope RT (%)	N/A
N/A	Flare Traversable LT?	N/A	N/A	Flare Traversable RT?	N/A
N/A	Landing Length (in)	N/A	N/A	DWS Provided?	N/A
N/A	Landing Width (in)	N/A	N/A	DWS Contrast?	N/A
N/A	Landing Slope (%)	N/A	N/A	DWS Length (in)	N/A
N/A	Landing X Slope (%)	N/A	N/A	DWS Full Width?	N/A
N/A	Landing Curb? (Y/N)	N/A	N/A	DWS Offset (in)	N/A
N/A	Shared Landing?	N/A			
N/A	Gutter Ponding?	N/A	N/A	Gutter Slope (%)	N/A
N/A	Gutter Lip Ht (in)	N/A	N/A	Gutter X Slope (%)	N/A
N/A	Painted X Walk1?	No	N/A	Painted X Walk2?	N/A
	X Walk 1 Direction	To NW		X Walk 2 Direction	N/A
N/A	X Walk 1 Width (in)	N/A	N/A	X Walk 2 Width (in)	N/A
	X Walk 1 Slope (%)	3.6		X Walk 2 Slope (%)	N/A
	X Walk 1 X Slope (%)	3.6		X Walk 2 X Slope (%)	N/A

Remove & Replace Entire Ramp.
