Access Compliance Report Public Rights-of-Way (Curb Ramps)

Intersection ID: 10024504 Main Street: CRUMP RD Cross Street: N/A Location: NW **Overall Compliance: No** ADA ID: 68AB9D33797F Ramp Type: Perp Initial Pass/Fail: Fail **Severity Score:** 10

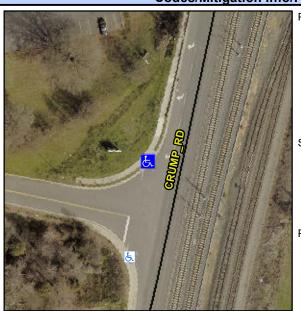
| i ossibie odiation | | | | |
|---|---|--|--|--|
| R304.5.1, R304.5.3 | N/ | | | |

| Field Measurements/Component Compliance | | | | | | | | |
|---|---|---|---|---|---|---|--|--|
| N/A | Ramp Length (in) | 106.0 | Yes | Ram | Slope (%) | 6.0 | | |
| No | Ramp Width (in) | 47.5 | No | Ram | XSlope (%) | 2.8 | | |

| i ossibie odiation | | | | |
|---|---|--|--|--|
| Remove & Replace Entire Ramp. | | | | |
