Intersection ID: 9159	Main Street: CAMPUS_ST	Cross Street: TATE_ST	Location:	NW
ADA ID: 68B6C971411E	Ramp Type: BlendTrans2	Initial Pass/Fail: Fail	Overall Compliance: No	Severity Score: 36.25

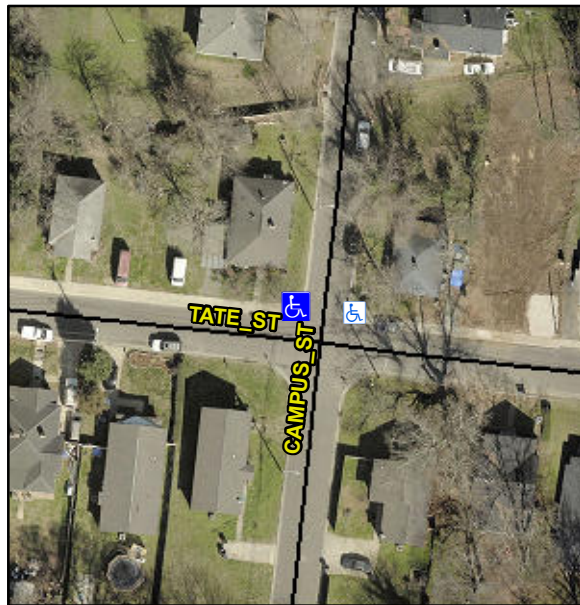
NO RT SW

Not Found, R304.5.1, R304.5.3

Compliance	Description	Data	Compliance	Description	Data
N/A	Ramp Length (in)	61.0	Yes	BlendTrans Slope (%)	1.9
No	Ramp Width (in)	24.5	No	BlendTrans XSlope (%)	3.1
N/A	Flare Type LT	N/A	N/A	Flare Type RT	N/A
N/A	Flare Slope LT (%)	N/A	N/A	Flare Slope RT (%)	N/A
N/A	Flare Traversable LT?	N/A	N/A	Flare Traversable RT?	N/A
N/A	Landing Length (in)	N/A	N/A	DWS Provided?	N/A
N/A	Landing Width (in)	N/A	N/A	DWS Contrast?	N/A
N/A	Landing Slope (%)	N/A	N/A	DWS Length (in)	N/A
N/A	Landing X Slope (%)	N/A	N/A	DWS Full Width?	N/A
N/A	Landing Curb? (Y/N)	N/A	N/A	DWS Offset (in)	N/A
N/A	Shared Landing?	N/A			
N/A	Gutter Ponding?	N/A	N/A	Gutter Slope (%)	N/A
N/A	Gutter Lip Ht (in)	N/A	N/A	Gutter X Slope (%)	N/A
N/A	Painted X Walk1?	No	N/A	Painted X Walk2?	N/A
	X Walk 1 Direction	To E		X Walk 2 Direction	N/A
	X Walk 1 Width (in)	N/A		X Walk 2 Width (in)	N/A
	X Walk 1 Slope (%)	0.1		X Walk 2 Slope (%)	N/A
	X Walk 1 X Slope (%)	3.4		X Walk 2 X Slope (%)	N/A

N/A	Ramp inside XWalk1?	N/A	N/A	Ramp inside XWalk2?	N/A
	Road Slope (%)	3.4		Clear Space?	N/A
	Road X Slope (%)	0.1	N/A	Clear Space to XWalk (in)	N/A
N/A	Any Obstructions?	N/A	N/A	Storm Grate/Utility Hazard?	N/A
	Obstruction Type			Storm Grate/Utility Type	
		N/A			N/A
			Yes	Surface Condition? (G/P)	Good
			No	Curb Slope (%)	13.1

Remove & Replace Curb Ramp With Two New Directional Ramps or Equivalent.
