Access Compliance Report

Public Rights-of-Way

(Curb Ramps)

| Intersection ID: 27431 | Main Street: BALLANTYNE COMMONS PY | Cross Street: RUSHMORE DR | Location: | NW |

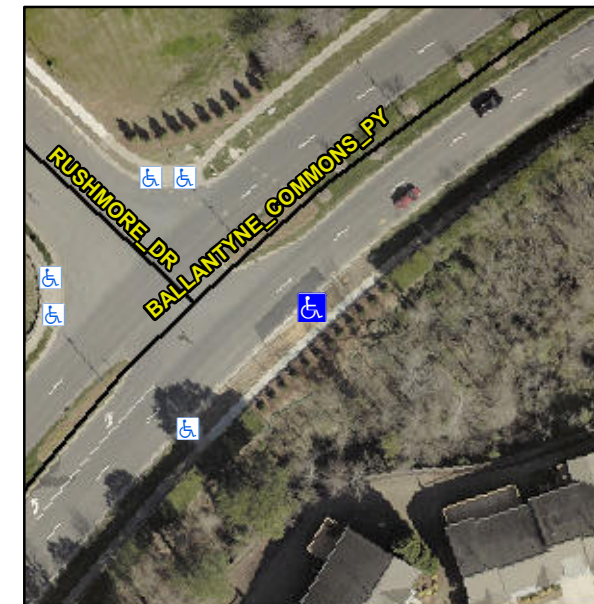
| ADA ID: 68C2FBCABCA9 | Ramp Type: Perp | Initial Pass/Fail: Fail | Overall Compliance: No | Severity Score: 12.5 |

N/A

Not Found, R304.5.3

| Compliance | Description | Data | Compliance | Description | Data |
|---|---|---|---|---|---|
| Yes | Ramp Width (in) | 49.0 | No | Ramp XSlope (%) | 5.3 |

Remove & Replace Entire Ramp.

Total Cost: \$ 1850.00
