# Access Compliance Report

## Public Rights-of-Way

### (Curb Ramps)

Intersection ID: 27409	Main Street: VALLEY_SPRING_DR	Cross Street: WOLF_DEN_LN	Location: N
ADA ID: 68C3CE565BEF	Ramp Type: PerpDiag	Initial Pass/Fail: Fail	Overall Compliance: No
Severity Score: 13.75			
Codes/Mitigation Info/Possible Solution		Field Measurements/Component Compliance

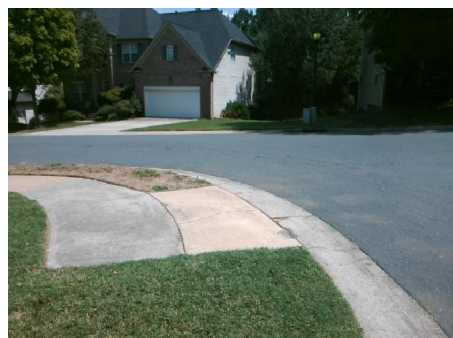
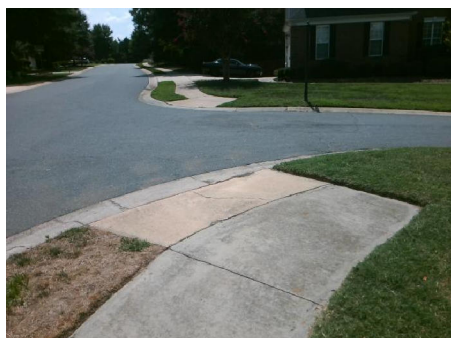
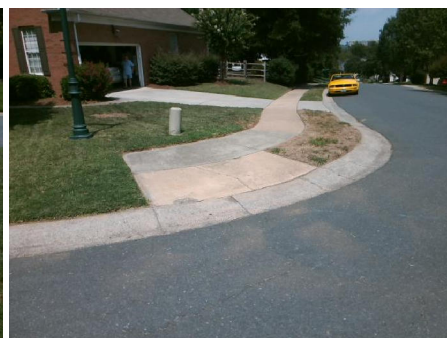
Compliance	Description	Data	Compliance	Description	Data
N/A	Ramp Length (in)	47.0	No	Ramp Slope (%)	8.4
Yes	Ramp Width (in)	48.0	No	Ramp XSlope (%)	3.5
N/A	Flare Type LT	N/A	N/A	Flare Type RT	N/A
N/A	Flare Slope LT (%)	N/A	N/A	Flare Slope RT (%)	N/A
N/A	Flare Traversable LT?	N/A	N/A	Flare Traversable RT?	N/A
N/A	Landing Length (in)	N/A	N/A	DWS Provided?	N/A
N/A	Landing Width (in)	N/A	N/A	DWS Contrast?	N/A
N/A	Landing Slope (%)	N/A	N/A	DWS Length (in)	N/A
N/A	Landing X Slope (%)	N/A	N/A	DWS Full Width?	N/A
N/A	Landing Curb? (Y/N)	N/A	N/A	DWS Offset (in)	N/A
N/A	Shared Landing?	N/A			
N/A	Gutter Ponding?	N/A	N/A	Gutter Slope (%)	N/A
N/A	Gutter Lip Ht (in)	N/A	N/A	Gutter X Slope (%)	N/A
N/A	Painted X Walk1?	No	N/A	Painted X Walk2?	No
	X Walk 1 Direction	To SW		X Walk 2 Direction	To SE
N/A	X Walk 1 Width (in)	N/A	N/A	X Walk 2 Width (in)	N/A
	X Walk 1 Slope (%)	5.7		X Walk 2 Slope (%)	1.3
	X Walk 1 X Slope (%)	1.4		X Walk 2 X Slope (%)	3.9

N/A	Ramp inside XWalk1?	N/A	N/A	Ramp inside XWalk2?	N/A
	Road Slope (%)	1.2	N/A	Clear Space?	N/A
	Road X Slope (%)	5.6	N/A	Clear Space to XWalk (in)	N/A
N/A	Any Obstructions?	N/A	N/A	Storm Grate/Utility Hazard?	N/A
	Obstruction Type			Storm Grate/Utility Type	
		N/A			N/A
			Yes	Surface Condition? (G/P)	Good

**Remove & Replace Curb Ramp With Two New Directional Ramps or Equivalent.**

**R304.2.2, R304.5.3**
