# Access Compliance Report

## Public Rights-of-Way

### (Curb Ramps)

Intersection ID: 21433	Main Street: PARK_RD	Cross Street: SPRING_VALLEY_RD	Location: SW
ADA ID: 68C5B49BAF46	Ramp Type: PerpDiag	Initial Pass/Fail: Fail	Overall Compliance: No
Severity Score: 13.75			
Codes/Mitigation Info/Possible Solution		Field Measurements/Component Compliance

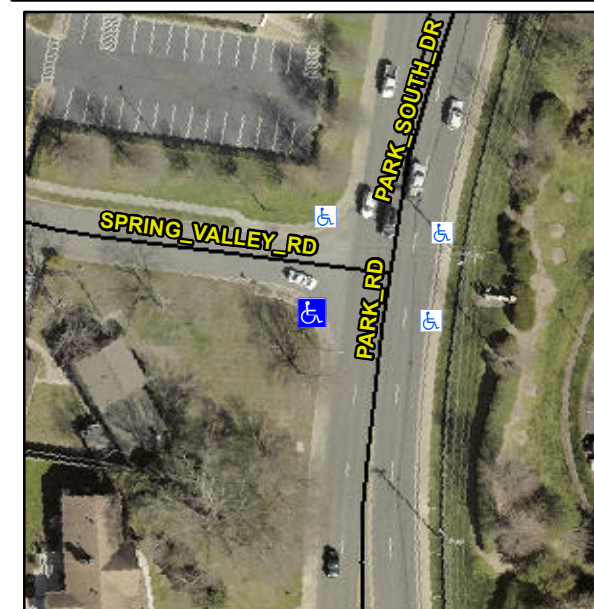
**Not Found, R304.2.2, R304.5.3**

Compliance	Description	Data	Compliance	Description	Data
N/A	Ramp Length (in)	54.0	No	Ramp Slope (%)	8.6
Yes	Ramp Width (in)	48.0	No	Ramp XSlope (%)	3.5
N/A	Flare Type LT	N/A	N/A	Flare Type RT	N/A
N/A	Flare Slope LT (%)	N/A	N/A	Flare Slope RT (%)	N/A
N/A	Flare Traversable LT?	N/A	N/A	Flare Traversable RT?	N/A
N/A	Landing Length (in)	N/A	N/A	DWS Provided?	N/A
N/A	Landing Width (in)	N/A	N/A	DWS Contrast?	N/A
N/A	Landing Slope (%)	N/A	N/A	DWS Length (in)	N/A
N/A	Landing X Slope (%)	N/A	N/A	DWS Full Width?	N/A
N/A	Landing Curb? (Y/N)	N/A	N/A	DWS Offset (in)	N/A
N/A	Shared Landing?	N/A			
N/A	Gutter Ponding?	N/A	N/A	Gutter Slope (%)	N/A
N/A	Gutter Lip Ht (in)	N/A	N/A	Gutter X Slope (%)	N/A
N/A	Painted X Walk1?	No	N/A	Painted X Walk2?	No
	X Walk 1 Direction	To SE		X Walk 2 Direction	To NE
N/A	X Walk 1 Width (in)	N/A	N/A	X Walk 2 Width (in)	N/A
	X Walk 1 Slope (%)	0.7		X Walk 2 Slope (%)	2.3
	X Walk 1 X Slope (%)	1.7		X Walk 2 X Slope (%)	0.8

N/A	Ramp inside XWalk1?	N/A	N/A	Ramp inside XWalk2?	N/A
	Road Slope (%)	1.9	N/A	Clear Space?	N/A
	Road X Slope (%)	0.9	N/A	Clear Space to XWalk (in)	N/A
N/A	Any Obstructions?	N/A	N/A	Storm Grate/Utility Hazard?	N/A
	Obstruction Type			Storm Grate/Utility Type	
		N/A			N/A
			Yes	Surface Condition? (G/P)	Good

**Remove & Replace Curb Ramp With Two New Directional Ramps or Equivalent.**

Total Cost: \$ 3200.00
