# Access Compliance Report

## Public Rights-of-Way

Intersection ID: 25995	Main Street: WEDDINGTON_RD	Cross Street: PLANTATION_CENTER_DR	Location: SW
ADA ID: 68CCE6F13AEE	Ramp Type: Para	Initial Pass/Fail: Fail	Overall Compliance: No
Codes/Mitigation Info/Possible Solution		Field Measurements/Component Compliance	
Severity Score: 26.25

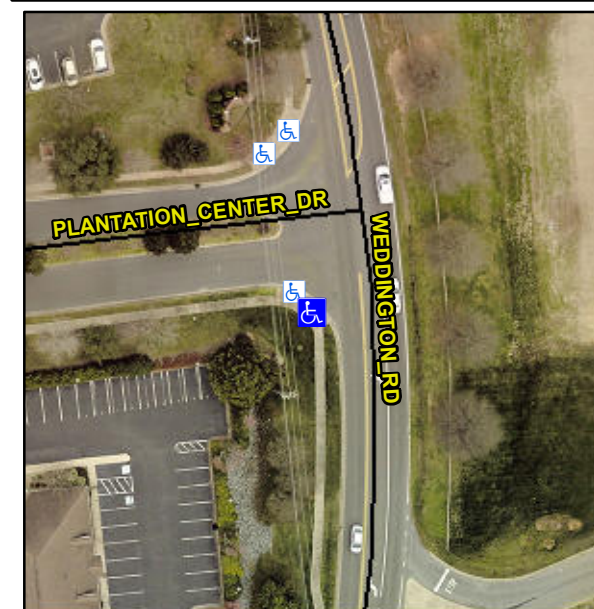
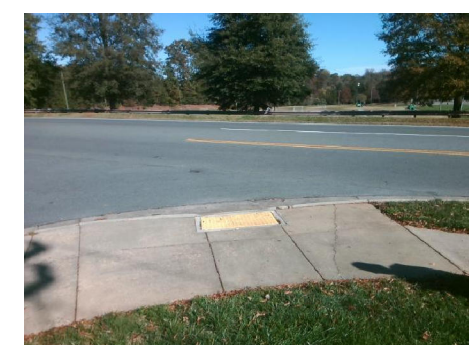
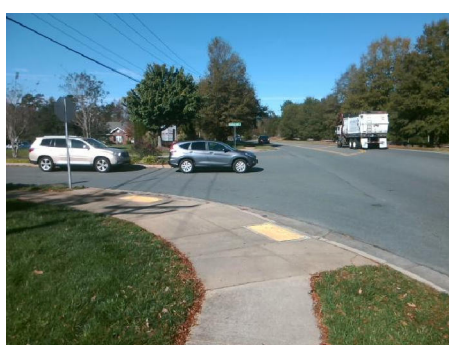
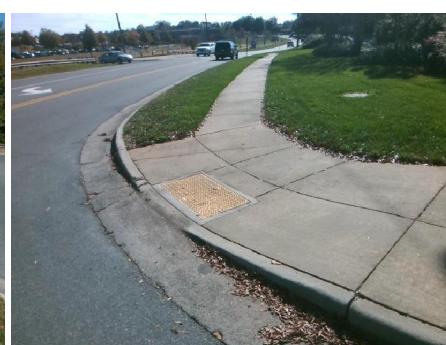
Compliance	Description	Data	Compliance	Description	Data
N/A	Ramp Length LT (in)	59.0	N/A	Ramp Length RT (in)	57.0
Yes	Ramp Width LT (in)	108.0	Yes	Ramp Width RT (in)	108.0
Yes	Ramp Slope LT (%)	5.4	No	Ramp Slope RT (%)	12.4
No	Ramp XSlope LT (%)	2.4	Yes	Ramp XSlope RT (%)	1.4
N/A	Landing Length (in)	N/A	N/A	DWS Provided?	N/A
N/A	Landing Width (in)	N/A	N/A	DWS Contrast?	N/A
N/A	Landing Slope (%)	N/A	N/A	DWS Length (in)	N/A
N/A	Landing X Slope (%)	N/A	N/A	DWS Full Width?	N/A
N/A	Landing Curb? (Y/N)	N/A	N/A	DWS Offset (in)	N/A
N/A	Shared Landing?	N/A			
N/A	Gutter Ponding?	N/A	N/A	Gutter Slope (%)	N/A
N/A	Gutter Lip Ht (in)	N/A	N/A	Gutter X Slope (%)	N/A
N/A	Painted X Walk1?	No	N/A	Painted X Walk2?	N/A
	X Walk 1 Direction	To E		X Walk 2 Direction	N/A
N/A	X Walk 1 Width (in)	N/A	N/A	X Walk 2 Width (in)	N/A
	X Walk 1 Slope (%)	3.0		X Walk 2 Slope (%)	N/A
	X Walk 1 X Slope (%)	3.6		X Walk 2 X Slope (%)	N/A
N/A	Ramp inside XWalk1?	N/A	N/A	Ramp inside XWalk2?	N/A

Road Slope (%)	N/A	N/A	Clear Space?	N/A
	Road X Slope (%)	N/A	N/A	Clear Space to XWalk (in)	N/A
N/A	Any Obstructions?	N/A	N/A	Storm Grate/Utility Hazard?	N/A
	Obstruction Type			Storm Grate/Utility Type	
		N/A			N/A
			Yes	Surface Condition? (G/P)	Good
			N/A	Curb Slope (%)	12.8

**Remove & Replace Entire Ramp.**

**R304.5.3, R304.3.2**
