Access Compliance Report

Public Rights-of-Way

(Curb Ramps)

Intersection ID: 26423	Main Street: BEVINGTON_PL	Cross Street: SILVER_PINE_DR	Location: NW
ADA ID: 68D8926567A6	Ramp Type: PerpDiag	Initial Pass/Fail: Fail	Overall Compliance: No
		Severity Score: 12.5

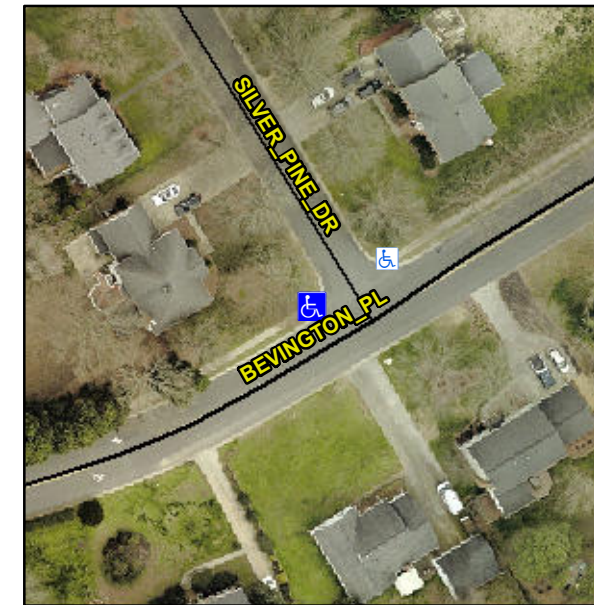
Compliance	Description	Data	Compliance	Description	Data
N/A	Ramp Length (in)	42.0	Yes	Ramp Slope (%)	6.6
Yes	Ramp Width (in)	48.0	No	Ramp XSlope (%)	6.1
N/A	Flare Type LT	N/A	N/A	Flare Type RT	N/A
N/A	Flare Slope LT (%)	N/A	N/A	Flare Slope RT (%)	N/A
N/A	Flare Traversable LT?	N/A	N/A	Flare Traversable RT?	N/A
N/A	Landing Length (in)	N/A	N/A	DWS Provided?	N/A
N/A	Landing Width (in)	N/A	N/A	DWS Contrast?	N/A
N/A	Landing Slope (%)	N/A	N/A	DWS Length (in)	N/A
N/A	Landing X Slope (%)	N/A	N/A	DWS Full Width?	N/A
N/A	Landing Curb? (Y/N)	N/A	N/A	DWS Offset (in)	N/A
N/A	Shared Landing?	N/A			
N/A	Gutter Ponding?	N/A	N/A	Gutter Slope (%)	N/A
N/A	Gutter Lip Ht (in)	N/A	N/A	Gutter X Slope (%)	N/A
N/A	Painted X Walk1?	No	N/A	Painted X Walk2?	No
	X Walk 1 Direction	To SE		X Walk 2 Direction	To NE
N/A	X Walk 1 Width (in)	N/A	N/A	X Walk 2 Width (in)	N/A
	X Walk 1 Slope (%)	8.2		X Walk 2 Slope (%)	0.6
	X Walk 1 X Slope (%)	0.4		X Walk 2 X Slope (%)	5.0

N/A	Ramp inside XWalk1?	N/A	N/A	Ramp inside XWalk2?	N/A
	Road Slope (%)	3.4	N/A	Clear Space?	N/A
	Road X Slope (%)	2.2	N/A	Clear Space to XWalk (in)	N/A
N/A	Any Obstructions?	N/A	N/A	Storm Grate/Utility Hazard?	N/A
	Obstruction Type			Storm Grate/Utility Type	
		N/A			N/A
			Yes	Surface Condition? (G/P)	Good

Remove & Replace Curb Ramp With Two New Directional Ramps or Equivalent.
