Access Compliance Report

Public Rights-of-Way

(Curb Ramps)

Intersection ID: 44295	Main Street: PEACHWOOD_DR	Cross Street: ROCKWOOD_RD	Location: SE
ADA ID: 68E44E361F97	Ramp Type: PerpDiag	Initial Pass/Fail: Fail	Overall Compliance: No
Codes/Mitigation Info/Possible Solution		Field Measurements/Component Compliance	
Severity Score: 10

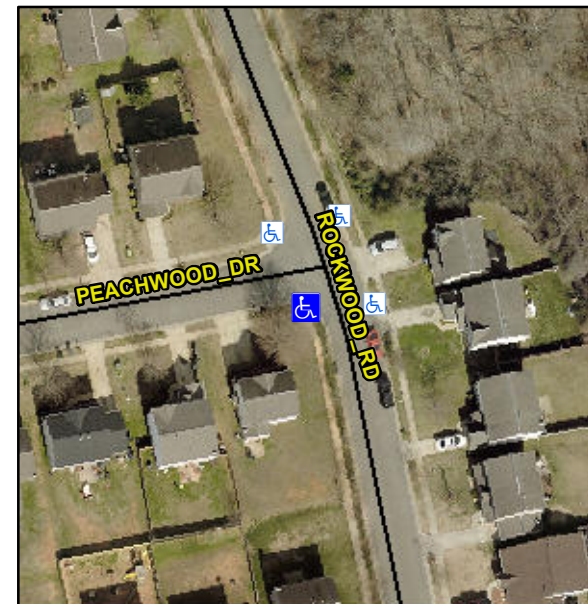
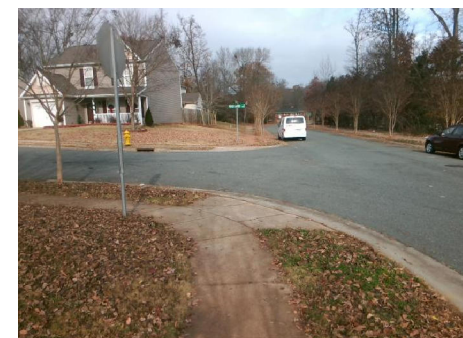
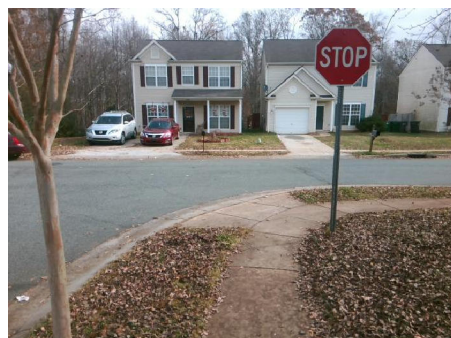
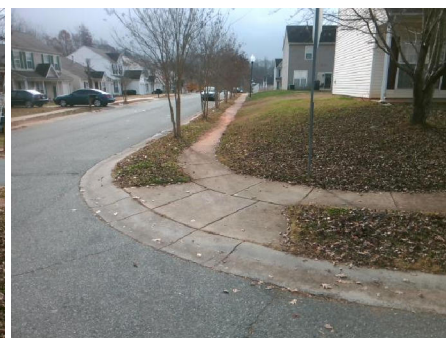
Not Found, R304.5.1, R304.5.3

Compliance	Description	Data	Compliance	Description	Data
N/A	Ramp Length (in)	45.0	Yes	Ramp Slope (%)	7.1
No	Ramp Width (in)	41.5	No	Ramp XSlope (%)	2.1
N/A	Flare Type LT	N/A	N/A	Flare Type RT	N/A
N/A	Flare Slope LT (%)	N/A	N/A	Flare Slope RT (%)	N/A
N/A	Flare Traversable LT?	N/A	N/A	Flare Traversable RT?	N/A
N/A	Landing Length (in)	N/A	N/A	DWS Provided?	N/A
N/A	Landing Width (in)	N/A	N/A	DWS Contrast?	N/A
N/A	Landing Slope (%)	N/A	N/A	DWS Length (in)	N/A
N/A	Landing X Slope (%)	N/A	N/A	DWS Full Width?	N/A
N/A	Landing Curb? (Y/N)	N/A	N/A	DWS Offset (in)	N/A
N/A	Shared Landing?	N/A			
N/A	Gutter Ponding?	N/A	N/A	Gutter Slope (%)	N/A
N/A	Gutter Lip Ht (in)	N/A	N/A	Gutter X Slope (%)	N/A
N/A	Painted X Walk1?	No	N/A	Painted X Walk2?	No
	X Walk 1 Direction	To W		X Walk 2 Direction	To N
N/A	X Walk 1 Width (in)	N/A	N/A	X Walk 2 Width (in)	N/A
	X Walk 1 Slope (%)	1.2		X Walk 2 Slope (%)	1.0
	X Walk 1 X Slope (%)	1.1		X Walk 2 X Slope (%)	0.3

N/A	Ramp inside XWalk1?	N/A	N/A	Ramp inside XWalk2?	N/A
	Road Slope (%)	2.2	N/A	Clear Space?	N/A
	Road X Slope (%)	2.1	N/A	Clear Space to XWalk (in)	N/A
N/A	Any Obstructions?	N/A	N/A	Storm Grate/Utility Hazard?	N/A
	Obstruction Type			Storm Grate/Utility Type	
		N/A			N/A
			Yes	Surface Condition? (G/P)	Good

Remove & Replace Curb Ramp With Two New Directional Ramps or Equivalent.
