Access Compliance Report

Public Rights-of-Way

(Curb Ramps)

Intersection ID: 12268	Main Street: BELLE_TERRE_AV	Cross Street: THE_PLAZA	Location: NE
ADA ID: 68E8AF3B8265	Ramp Type: Directional1	Initial Pass/Fail: Fail	Overall Compliance: No
		Severity Score: 12.5

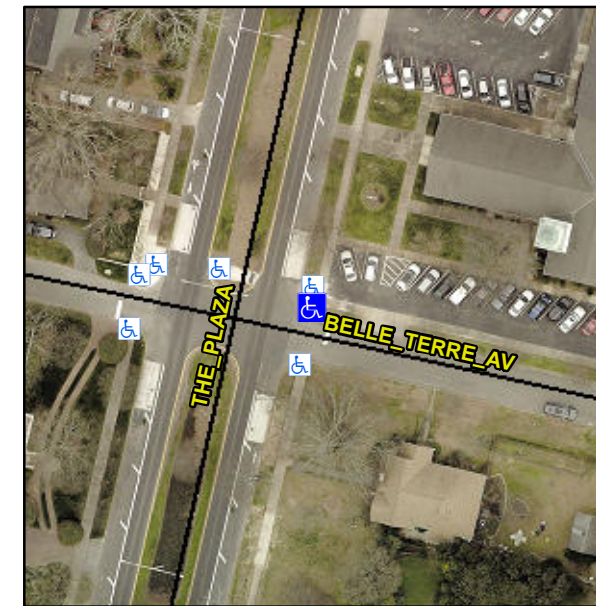
Compliance	Description	Data	Compliance	Description	Data
N/A	Ramp Length (in)	53.5	N/A	Grade Break?	N/A
Yes	Ramp Width (in)	60.5	N/A	Grade Break Slope (%)	0.0
No	Ramp Slope (%)	8.7	N/A	Grade Break XSlope (%)	0.0
Yes	Ramp XSlope (%)	1.8			
N/A	Flare Type LT	N/A	N/A	Flare Type RT	N/A
N/A	Flare Slope LT (%)	N/A	N/A	Flare Slope RT (%)	0.0
N/A	Flare Traversable LT?	N/A	N/A	Flare Traversable RT?	N/A
N/A	Landing Length (in)	0.0	N/A	DWS Provided?	N/A
N/A	Landing Width (in)	0.0	N/A	DWS Contrast?	N/A
N/A	Landing Slope (%)	0.0	N/A	DWS Length (in)	N/A
N/A	Landing X Slope (%)	0.0	N/A	DWS Full Width?	N/A
N/A	Landing Curb? (Y/N)	N/A	N/A	DWS Offset LT (in)	N/A
N/A	Shared Landing?	N/A	N/A	DWS Offset RT (in)	N/A
N/A	Gutter Ponding?	Yes	N/A	Gutter Slope (%)	N/A
N/A	Gutter Lip Ht (in)	0.0	N/A	Gutter X Slope (%)	N/A
N/A	Painted X Walk1?	No		Road Slope (%)	1.7
	X Walk 1 Direction	To S		Road X Slope (%)	1.8
	X Walk 1 Width (in)	N/A		Clear Space?	N/A

X Walk 1 Slope (%)	1.7	N/A	Clear Space to XWalk (in)	N/A
	X Walk 1 X Slope (%)	1.8	N/A	Storm Grate/Utility Hazard?	N/A
N/A	Ramp inside XWalk1?	N/A		Storm Grate/Utility Type	
N/A	Any Obstructions?	N/A			N/A
	Obstruction Type		Yes	Surface Condition? (G/P)	Good
			N/A	Curb Slope (%)	13.3

Remove & Replace Entire Ramp.
