Access Compliance Report

Public Rights-of-Way

(Curb Ramps)

Intersection ID: 30508	Main Street: PLANTERS_ESTATES_DR	Cross Street: SUNRISE_VIEW_DR	Location: SW
ADA ID: 68E8EC385D23	Ramp Type: PerpDiag	Initial Pass/Fail: Fail	Overall Compliance: No
Severity Score: 35			
Codes/Mitigation Info/Possible Solution		Field Measurements/Component Compliance

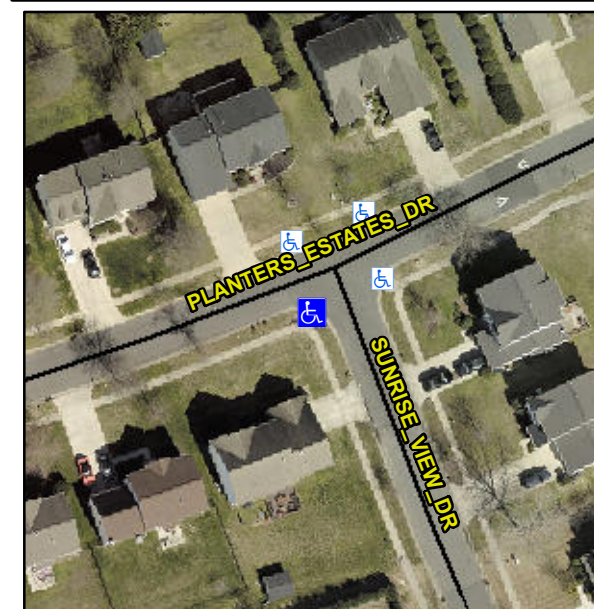
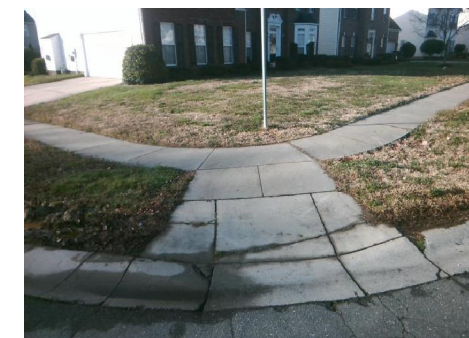
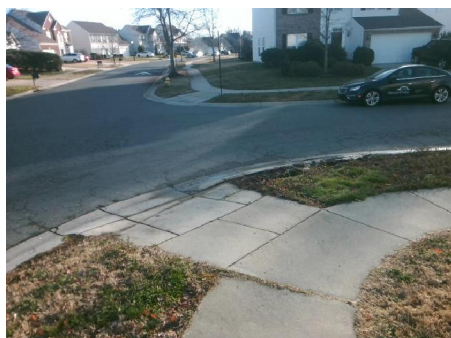
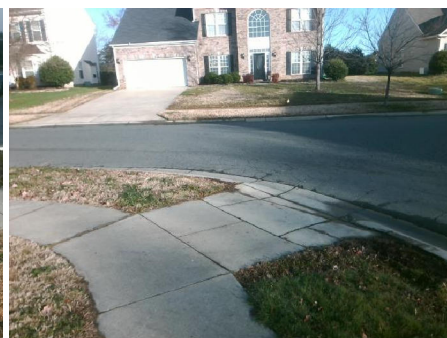
Not Found, R304.5.1, R304.2.2, R304.5.3

Compliance	Description	Data	Compliance	Description	Data
N/A	Ramp Length (in)	87.5	No	Ramp Slope (%)	13.0
No	Ramp Width (in)	46.5	No	Ramp XSlope (%)	2.5
N/A	Flare Type LT	N/A	N/A	Flare Type RT	N/A
N/A	Flare Slope LT (%)	N/A	N/A	Flare Slope RT (%)	N/A
N/A	Flare Traversable LT?	N/A	N/A	Flare Traversable RT?	N/A
N/A	Landing Length (in)	N/A	N/A	DWS Provided?	N/A
N/A	Landing Width (in)	N/A	N/A	DWS Contrast?	N/A
N/A	Landing Slope (%)	N/A	N/A	DWS Length (in)	N/A
N/A	Landing X Slope (%)	N/A	N/A	DWS Full Width?	N/A
N/A	Landing Curb? (Y/N)	N/A	N/A	DWS Offset (in)	N/A
N/A	Shared Landing?	N/A			
N/A	Gutter Ponding?	N/A	N/A	Gutter Slope (%)	N/A
N/A	Gutter Lip Ht (in)	N/A	N/A	Gutter X Slope (%)	N/A
N/A	Painted X Walk1?	No	N/A	Painted X Walk2?	No
	X Walk 1 Direction	To NE		X Walk 2 Direction	To NW
N/A	X Walk 1 Width (in)	N/A	N/A	X Walk 2 Width (in)	N/A
	X Walk 1 Slope (%)	1.3		X Walk 2 Slope (%)	5.1
	X Walk 1 X Slope (%)	3.2		X Walk 2 X Slope (%)	2.2

N/A	Ramp inside XWalk1?	N/A	N/A	Ramp inside XWalk2?	N/A
	Road Slope (%)	4.0	N/A	Clear Space?	N/A
	Road X Slope (%)	4.2	N/A	Clear Space to XWalk (in)	N/A
N/A	Any Obstructions?	N/A	N/A	Storm Grate/Utility Hazard?	N/A
	Obstruction Type			Storm Grate/Utility Type	
		N/A			N/A
			Yes	Surface Condition? (G/P)	Good

Possible Solutions:

Remove & Replace Curb Ramp With Two New Directional Ramps or Equivalent.
