Access Compliance Report

Public Rights-of-Way

(Curb Ramps)

Intersection ID: 30327	Main Street: FLYING_SCOTSMAN_DR	Cross Street: STOURBRIDGE_LION_DR	Location: E
ADA ID: 68E95AB7158B	Ramp Type: PerpDiag	Initial Pass/Fail: Fail	Overall Compliance: No
		Severity Score: 21.25

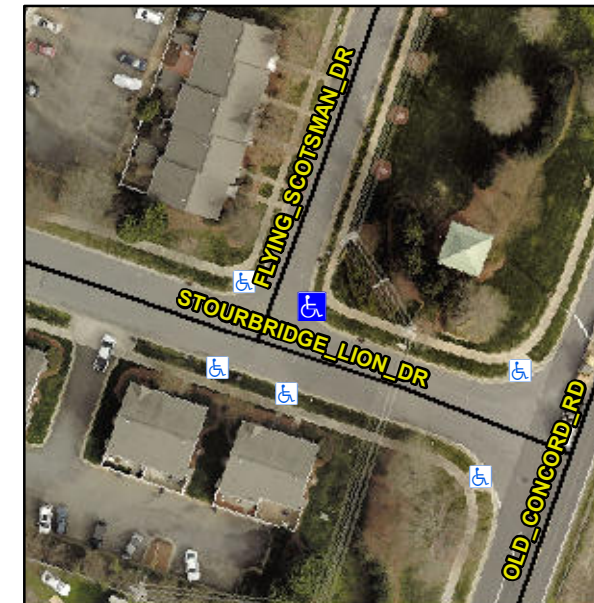
Compliance	Description	Data	Compliance	Description	Data
N/A	Ramp Length (in)	70.0	No	Ramp Slope (%)	10.4
No	Ramp Width (in)	47.5	Yes	Ramp XSlope (%)	0.3
N/A	Flare Type LT	N/A	N/A	Flare Type RT	N/A
N/A	Flare Slope LT (%)	N/A	N/A	Flare Slope RT (%)	N/A
N/A	Flare Traversable LT?	N/A	N/A	Flare Traversable RT?	N/A
N/A	Landing Length (in)	N/A	N/A	DWS Provided?	N/A
N/A	Landing Width (in)	N/A	N/A	DWS Contrast?	N/A
N/A	Landing Slope (%)	N/A	N/A	DWS Length (in)	N/A
N/A	Landing X Slope (%)	N/A	N/A	DWS Full Width?	N/A
N/A	Landing Curb? (Y/N)	N/A	N/A	DWS Offset (in)	N/A
N/A	Shared Landing?	N/A			
N/A	Gutter Ponding?	N/A	N/A	Gutter Slope (%)	N/A
N/A	Gutter Lip Ht (in)	1.0	N/A	Gutter X Slope (%)	N/A
N/A	Painted X Walk1?	No	N/A	Painted X Walk2?	No
	X Walk 1 Direction	To NW		X Walk 2 Direction	To SW
N/A	X Walk 1 Width (in)	N/A	N/A	X Walk 2 Width (in)	N/A
	X Walk 1 Slope (%)	1.0		X Walk 2 Slope (%)	2.9
	X Walk 1 X Slope (%)	1.3		X Walk 2 X Slope (%)	2.2

N/A	Ramp inside XWalk1?	N/A	N/A	Ramp inside XWalk2?	N/A
	Road Slope (%)	1.1	N/A	Clear Space?	N/A
	Road X Slope (%)	2.8	N/A	Clear Space to XWalk (in)	N/A
N/A	Any Obstructions?	N/A	N/A	Storm Grate/Utility Hazard?	N/A
	Obstruction Type			Storm Grate/Utility Type	
		N/A			N/A
			Yes	Surface Condition? (G/P)	Good

Remove & Replace Curb Ramp With Two New Directional Ramps or Equivalent.
