# Access Compliance Report

## Public Rights-of-Way

### (Curb Ramps)

Intersection ID: 48073	Main Street: MALLARD_HIGHLANDS_DR	Cross Street: MALLARD_GLEN_DR	Location: W
ADA ID: 68F3C498A4BA	Ramp Type: PerpDiag	Initial Pass/Fail: Fail	Overall Compliance: No
Severity Score: 42.5			
Codes/Mitigation Info/Possible Solution		Field Measurements/Component Compliance

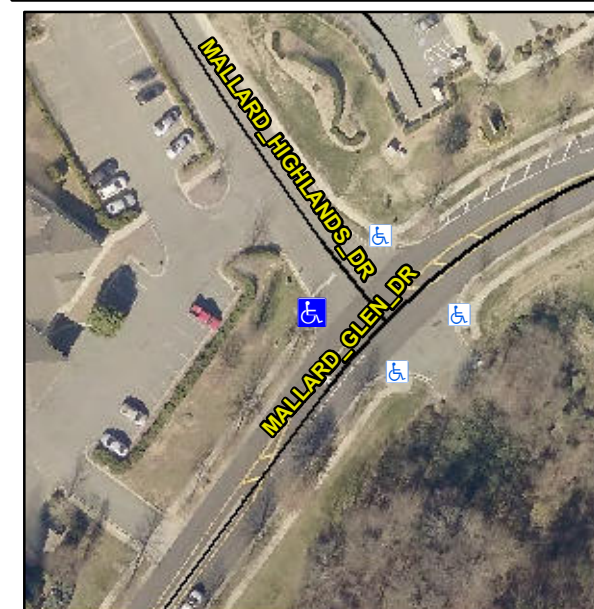
Compliance	Description	Data	Compliance	Description	Data
N/A	Ramp Length (in)	60.0	No	Ramp Slope (%)	14.0
No	Ramp Width (in)	35.0	Yes	Ramp XSlope (%)	1.6
N/A	Flare Type LT	N/A	N/A	Flare Type RT	N/A
N/A	Flare Slope LT (%)	N/A	N/A	Flare Slope RT (%)	N/A
N/A	Flare Traversable LT?	N/A	N/A	Flare Traversable RT?	N/A
N/A	Landing Length (in)	N/A	N/A	DWS Provided?	N/A
N/A	Landing Width (in)	N/A	N/A	DWS Contrast?	N/A
N/A	Landing Slope (%)	N/A	N/A	DWS Length (in)	N/A
N/A	Landing X Slope (%)	N/A	N/A	DWS Full Width?	N/A
N/A	Landing Curb? (Y/N)	N/A	N/A	DWS Offset (in)	N/A
N/A	Shared Landing?	N/A			
N/A	Gutter Ponding?	N/A	N/A	Gutter Slope (%)	N/A
N/A	Gutter Lip Ht (in)	N/A	N/A	Gutter X Slope (%)	N/A
N/A	Painted X Walk1?	No	N/A	Painted X Walk2?	No
	X Walk 1 Direction	To SE		X Walk 2 Direction	To NE
N/A	X Walk 1 Width (in)	N/A	N/A	X Walk 2 Width (in)	N/A
	X Walk 1 Slope (%)	1.8		X Walk 2 Slope (%)	2.1
	X Walk 1 X Slope (%)	2.5		X Walk 2 X Slope (%)	1.9

N/A	Ramp inside XWalk1?	N/A	N/A	Ramp inside XWalk2?	N/A
	Road Slope (%)	0.8	N/A	Clear Space?	N/A
	Road X Slope (%)	3.6	N/A	Clear Space to XWalk (in)	N/A
N/A	Any Obstructions?	N/A	N/A	Storm Grate/Utility Hazard?	N/A
	Obstruction Type			Storm Grate/Utility Type	
		N/A			N/A
			Yes	Surface Condition? (G/P)	Good

**Remove & Replace Curb Ramp With Two New Directional Ramps or Equivalent.**

**R304.5.1, R304.2.2**
